## Learning from Earthquakes

# The M<sub>w</sub> 7.1 Darfield (Canterbury), New Zealand Earthquake of September 4, 2010

From September 8th to 20th, 2010, a team organized by the Earthquake Engineering Research Institute (EERI) and the Pacific Earthquake Engineering Research (PEER) Center investigated the effects of the Darfield earthquake. The team was led by Mary Comerio, UC Berkeley, and included Lucy Arendt, University of Wisconsin, Green Bay; Michel Bruneau, University of Buffalo, New York; Peter Dusicka, Portland State University; Henri Gavin, Duke University; Charles Roeder, University of Washington; and Fred Turner, California Seismic Safety Commission. Additionally, individuals sponsored by their organizations, or already in New Zealand, joined the team: Tao Lai, AIR Worldwide Corporation; Rob Williams and Oliver Boyd, US Geological Survey; Myrto Anagnostopoulou, University of Buffalo; and William Holmes, Rutherford and Chekene, LFE Program Manager. Thomas O'Rourke of Cornell University visited Christchurch the week of October 11th.

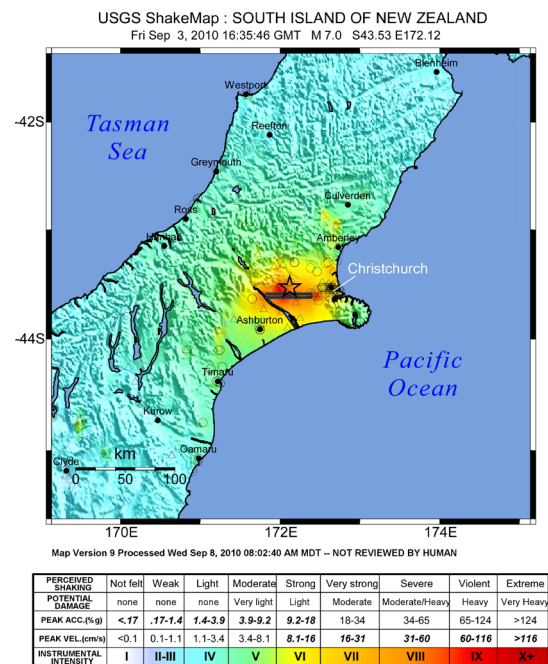
Figure 1. Location of epicenter and shaking intensity by city size (source: USGS)

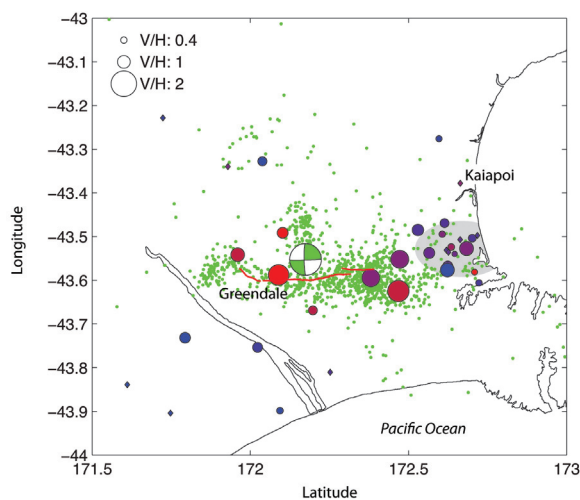
**Figure 2.** Strong motion stations, fault rupture (red line) and aftershocks (green circles). Gray area is the metropolitan area of Christchurch (source: USGS)

Very strong ground motions were recorded by strong motion seismometers near the rupture. Maximum felt intensities reached VIII (Figure 2). Maximum vertical peak ground acceleration at Greendale (located about 1 km north of the fault scarp) was 1.26 g. Horizontal peak ground

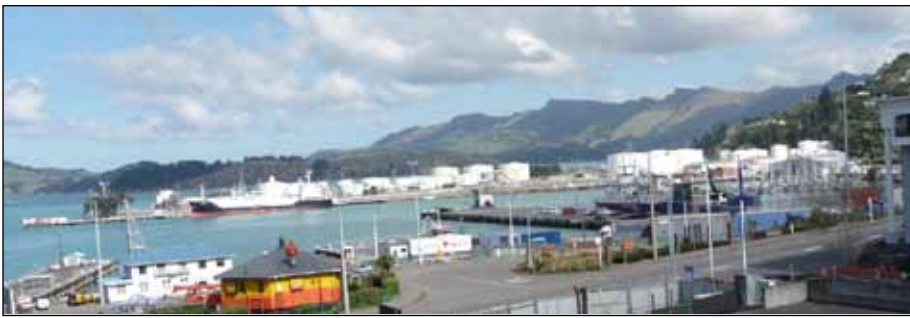
**Figure 6.** The port facility at Lyttelton (photo: Roeder).

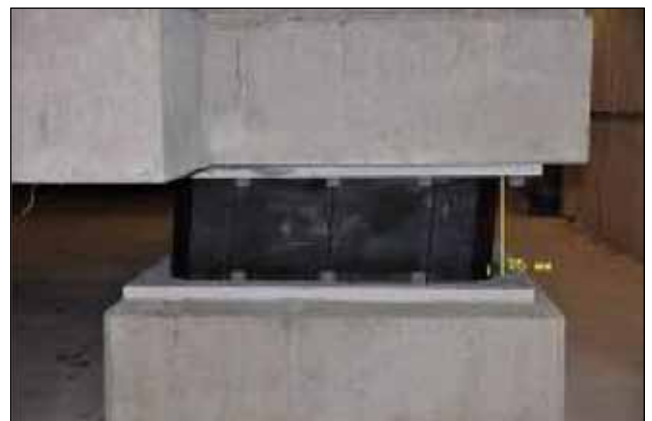
E-W direction. The estimated 70-90 mm peak isolator drifts are well below the 420 mm design displacement, for a 2,000-year return period demand. The estimated peak displacements are probably not inconsistent with the observation that spectral demands in Christchurch for this event were close to the 10%/50yr level for long-period structures (Figure 14).

**Figure 14.** Aspect of the base-isolated hospital building (source: Gavin).

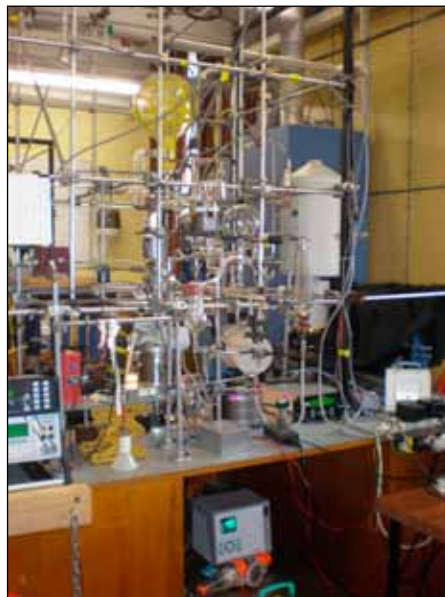
**Figure 18.** At the University of Canterbury, laboratory experiments had to be rebuilt. (photo: Comerio)

The university was initially closed for one week, but during the clean-up, it was decided to extend the closure for a second week, with a phased return of staff and students in the second week. Staff and graduate student researchers were allowed in to clean up their offices and make repairs (Figure 18), and faculty met to organize the teaching and exam schedule for the end of the semester.
