Learning from Earthquakes

The M_w 6.3 Abruzzo, Italy, Earthquake of April 6, 2009

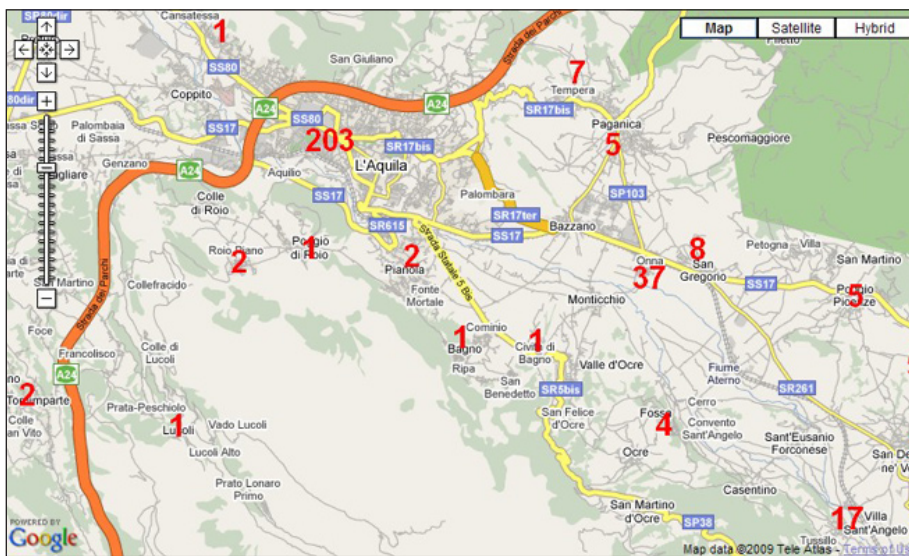
Figure 3. The L'Aquila area and the locations of fatalities.

The earthquake struck when most people were sleeping. The locations of the 305 deaths can be seen in Figure 3. The fatalities were concentrated in the 20-29 and over-70 age groups, though that does not reflect the more balanced demographics of L'Aquila province. The peak in the 20-29 group was due to the collapse of a student dormitory in downtown L'Aquila.

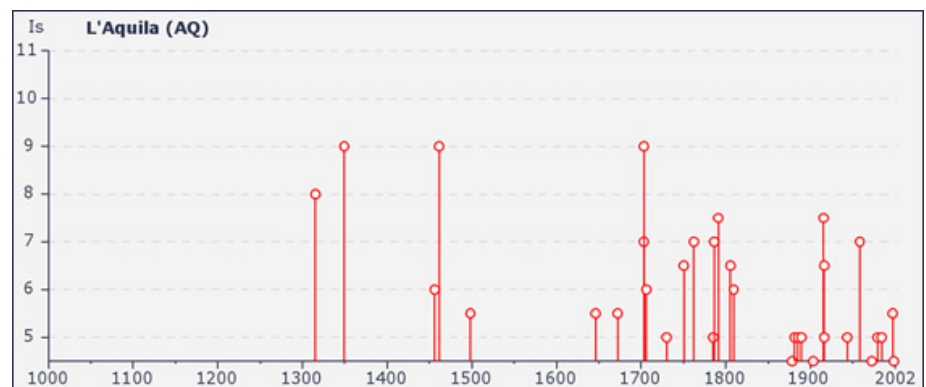
Figure 4. Historical MCS macroseismic intensity of the major events near L'Aquila since 1300.

Figure 4 shows the earthquakes that have struck the city of L'Aquila and the villages around it since 1300 (Stucchi et al., 2007; Rovida et al., 2009). L'Aquila has been severely damaged at least five times in the last 700 years, specifically in 1315 ($M_w \approx 6.7$), 1349 ($M_w \approx 6.5$), 1461 ($M_w \approx 6.5$), 1703 ($M_w \approx 6.7$), and 1915 ($M_w \approx 7.0$). The 1461 event shows a damage distribution similar to that of the April 6 earthquake, although it is shifted to the east by a few km.

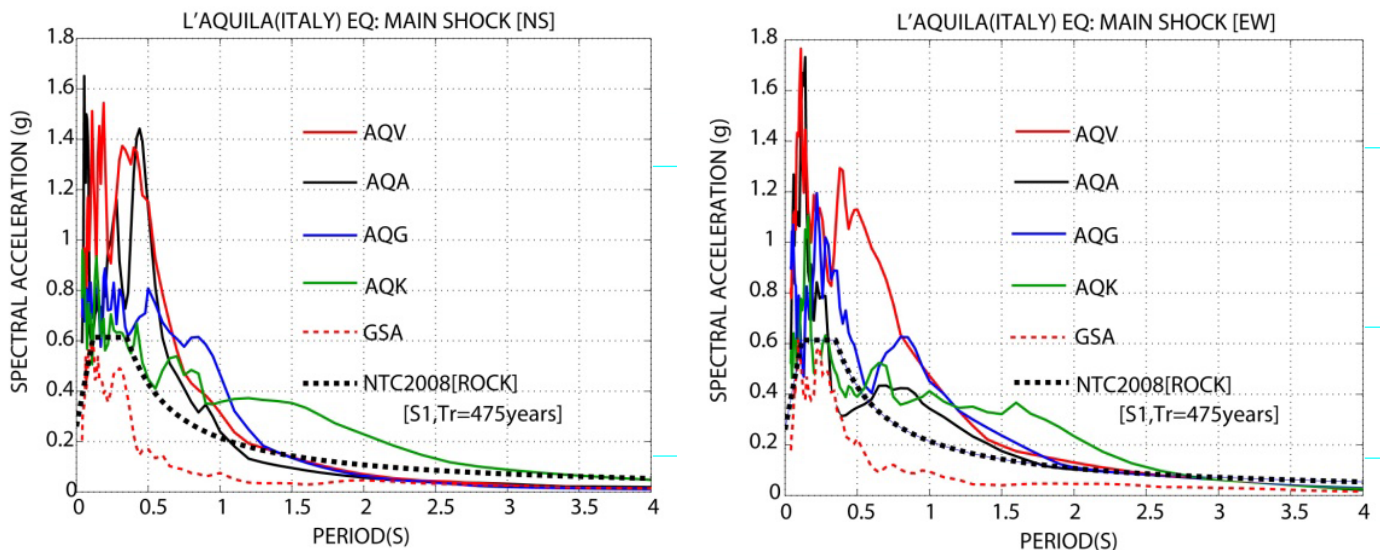
The 5%-damped spectra of the two horizontal directions produced by USGS for the stations in Table 1 have shown, with the exception of the AQK station, that the ground shaking had mostly a high-frequency content (Figure 5). The ground motion had also relatively short duration: 95% of the energy was released in 10 seconds or less. Finally, unprocessed data obtained from many stations show permanent displacements of up to 15 cm.

Figure 5. Response spectra for 5% damping for the 5 stations in Table 1 that recorded >0.1 g and comparison with 2008 Italian Code Spectrum.
