## Learning from Earthquakes

# Performance of Engineered Structures in the $M_w$ 9.0 Tohoku, Japan, Earthquake of March 11, 2011

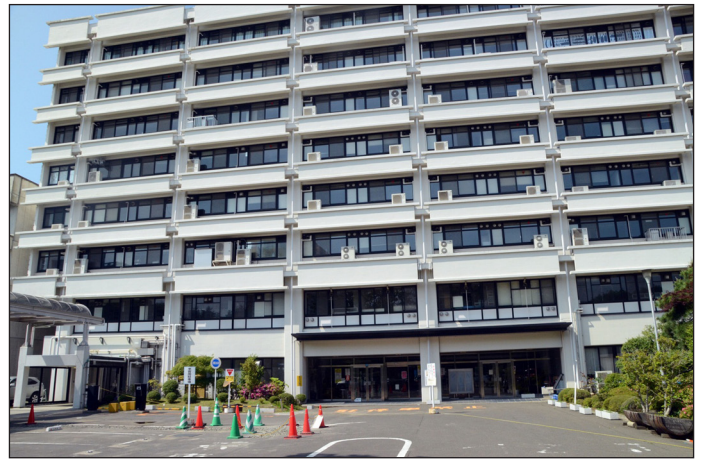
**Figure 11.** Electrical and Communication Engineering building, south elevation.

Also seriously damaged was the eight-story steel reinforced concrete Electrical and Communication Engineering Building (Figure 11) built in 1966, which was still closed to access in early July. At the east end of the building at the transverse walls, there was significant damage to the concrete girders that span between two concrete shear walls, particularly at the openings through the girders for mechanical ducting (Figure 12). Reportedly, the damage to these elements has been continuing (with increased cracking and spalling) in the aftershocks. Residual deformation of the external water pipes at the upper stories of this building indicates some higher mode effects during the earthquake. The coupling beams had circular mechanical penetrations and exhibited shear failures and bond-splitting failures at others. The shaking in this building was strong enough to topple anchored pressurized gas cylinders on the 7th floor, while those on the

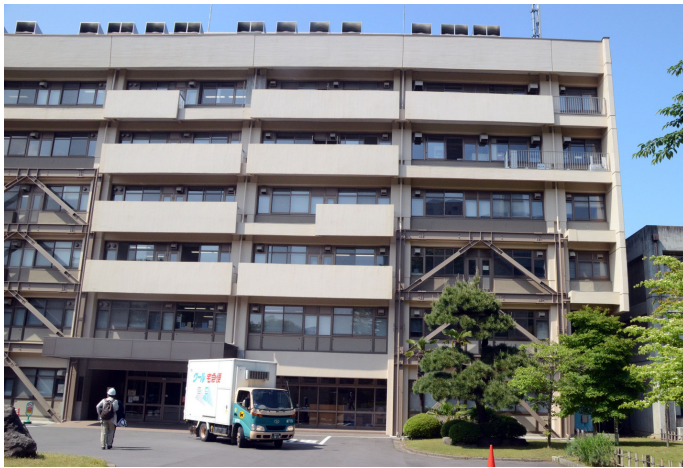
The Applied Chemistry and Chemical Engineering Building (Figure 14), also of reinforced concrete construction, had been previously strengthened with an external steel braced frame system. Connection details for the retrofit are shown in Figure 15. This building appeared to perform well, with no visible evidence of distress in the bracing members or connections.

**Figure 14.** Steel braced frames in Applied Chemistry & Chemical Engineering building.

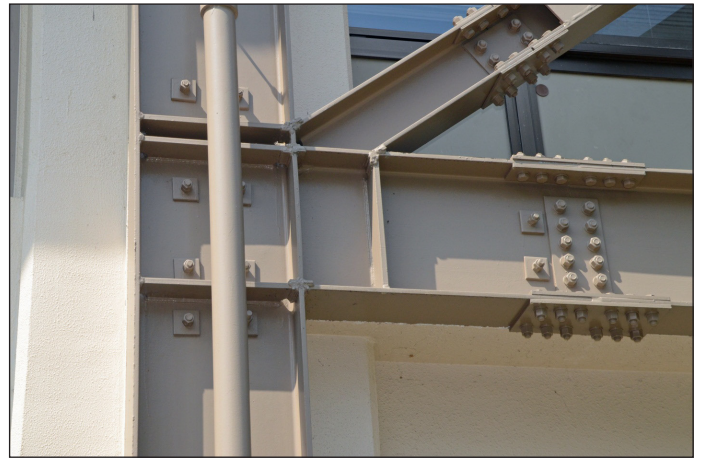
**Figure 15.** Steel strengthening of concrete building.

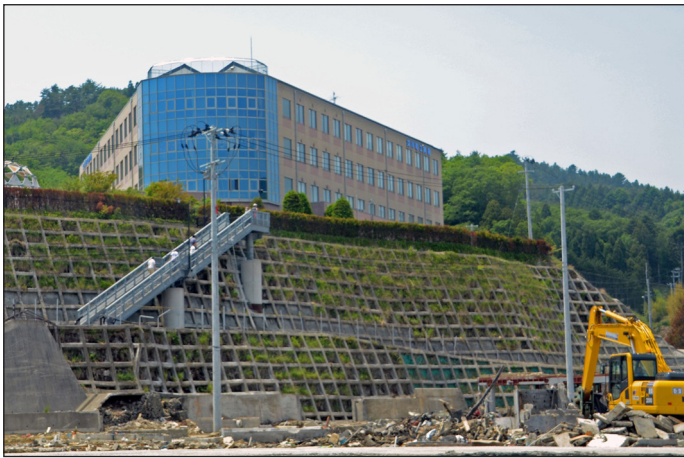
The team observed two hospitals that had been damaged by the tsunami. The town hospital in Onagawa is located on a hill above the harbor, at approximately 12-13m in elevation (Figure 25). Onagawa lies at the end of a narrow harbor and had tsunami heights reaching 15m that completely destroyed all buildings within the inundation zone.

**Figure 25.** Onagawa hospital on hill above the town.

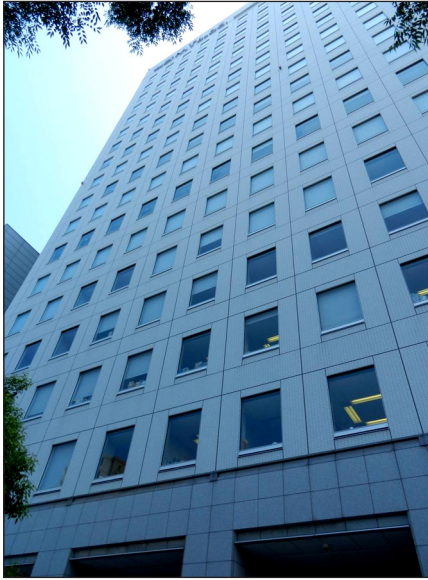
**Figure 29.** Sendai MT Building.

The 18-story Sendai MT office building in Sendai City (Figure 29) was constructed in 1999 and is supported on a combination of 26 rubber bearings and 10 flat sliding PTFE bearings (Figure 30).

There was no structural damage in the building and it was fully usable after the earthquake. Minor non-structural damage was observed in some joints covering the isolation gaps at the base of the building, but this damage was repairable and did not affect the functionality of the building.

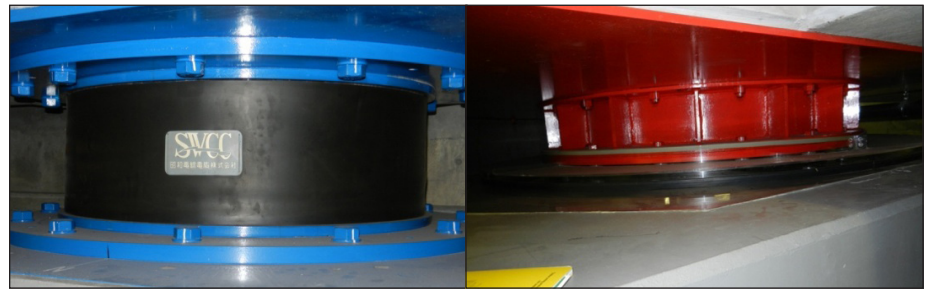
**Figure 30.** (left) Rubber isolation bearing, (right) sliding isolation bearing.

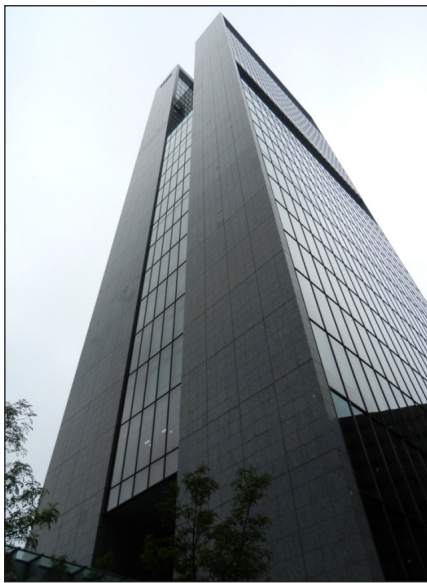
The Yozemi Tower (Figure 32) in central Tokyo incorporates a seismic isolation system combined with a semi-active damping system at the base isolation level. The building has 26 stories above grade, and three stories below grade. The

**Figure 32.** The Yozemi Tower in the Shinjuku area of Tokyo.

The maximum observed isolation system displacement in the earthquake was approximately 10 cm. There was no reported structural or nonstructural damage, and the building remained fully functional after the earthquake.

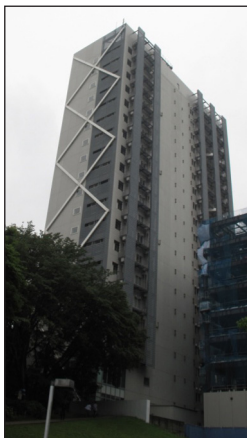
**Figure 36.** Tokyo Institute of Technology Building J2.

The 20-story J2 building of the Tokyo Institute of Technology (Figure 36) is a base-isolated building located on the Suzukakedai campus in Yokohama. The isolation system includes 16 rubber bearings acting in parallel with 14 yielding metal dampers and two oil (hydraulic) dampers (Figure 37a).

During the earthquake, the maximum measured radial displacement of the isolation system was approximately 12.5 cm (9.5 cm in the NE-SW direction). It is not known at this time whether there was uplift at any of the rubber bearings. The peak ground acceleration measured below the isolation plane was 69.0 cm/sec<sup>2</sup> in the NE-SW direction. At the first level above the isolation plane, the maximum acceleration in the NE-SW direction was 69.6 cm/sec<sup>2</sup>. The maximum acceleration at the 20th floor in the NE-SW direction was 116.2 cm/sec<sup>2</sup>. Comparing the peak ground acceleration and the peak acceleration at the 20th floor, it can be seen that the isolation system was highly effective at minimizing dynamic amplification of ground motions over the height of the building.

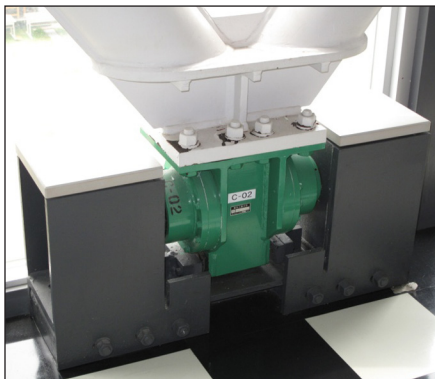
**Figure 42.** Tohoku Institute of Technology Building B10 supplemental damping.

**Buildings with Supplemental Damping Systems.** The Tohoku Institute of Technology campus outside of Sendai has two structures with protective systems; both were damaged during the earthquake. One of these structures, Building 10, was constructed in 2003 and demonstrates how excessive demands on dampers can lead to partial failure of the system. Building 10 is a seven-story structure with moment-resisting frames and four dampers in each direction at each floor. The first level of Building 10 is 8m high, and all upper stories are 3.8m high.

Presumably, the damping system was intended to control drifts and shaking duration during small events. Each damper frame bay holds a chevron brace with a horizontal damper connected between the tip of the chevron brace and a snubber assembly mounted at the

floor level below (see Figure 42). The damper device contains oil that is forced through a narrow orifice, in addition to a viscoelastic material that is engaged at the end of the damper stroke.

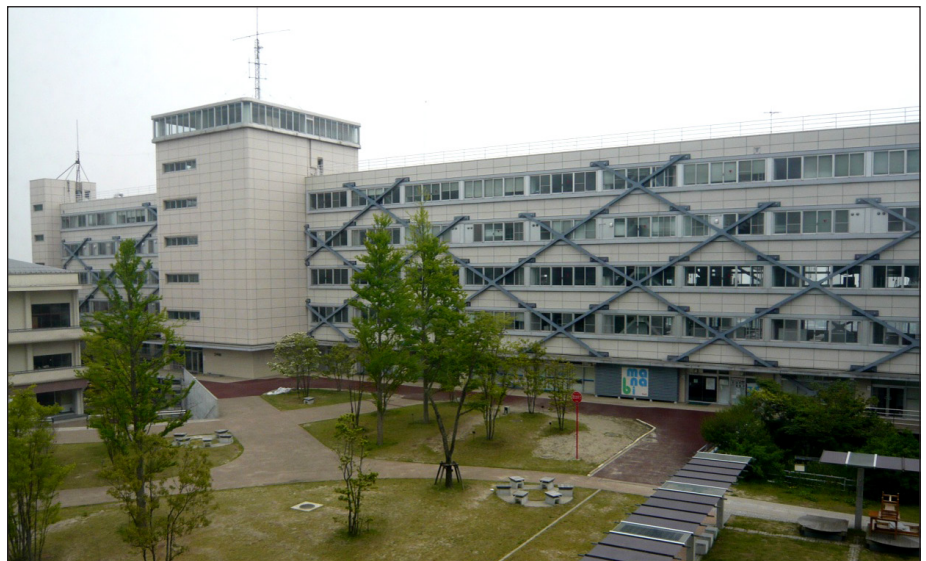
**Figure 43.** Tohoku Institute of Technology Building 5 with exterior bracing and interior supplemental damping.

Near Building 10 is an older structure, Building 5, an eight-story structure constructed in 1971 with a force-resisting system consisting of a nonductile concrete frame combined with concrete walls in the transverse (N-S) direction. In 1978, the Miyagi-ken-oki earthquake damaged the building, which was subsequently repaired and strengthened. The retrofit scheme consisted of steel cross-brace frames located on the exterior of the building in the longitudinal (E-W) direction (see Figure 43). The cross braces were constructed of wide flange steel

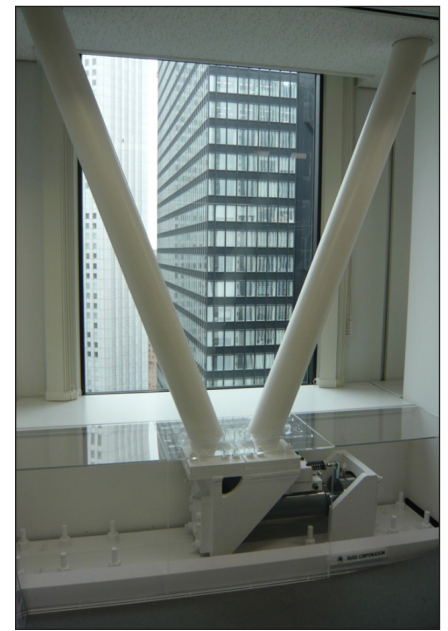
The EERI team visited the Shinjuku Center, a 54-story building in the Shinjuku area of Tokyo constructed in 1979. The structure's height is 223m, and the first natural period of the structure is 5.2 and 6.2 seconds in two perpendicular directions. In 2009, the building was retrofitted from the 15th to 39th floor with 288 oil dampers that were configured to exhibit a form of deformation dependency, in addition to velocity dependency (see Figure 44). Taisei Corporation developed this damper type for reinforcing existing high-rise buildings against long-period motions. Because the deformation-dependent damper is designed to reduce the damping force at the instant the frame deformation comes close to its maximum value, engineers determined that no reinforcement was needed in the surrounding columns, girders, and foundations. In the March quake, the dampers were calculated to have reduced the maximum accelerations by 30% and roof displacement by 22%. Acceleration data are not available at this time, but we do know that shaking in the structure lasted nearly 10 minutes without any reported structural or nonstructural damage.

**Figure 44.** Shinjuku Center Building retrofitted with damper brace.
