Cairo, Egypt, Earthquake of October 12, 1992

On October 12, 1992, at 3:10 p.m. local time, an earthquake of M_b 5.9 (M_s 5.4) occurred near Cairo, Egypt, that resulted in approximately 500 deaths, thousands of injuries, the collapse of a few structures, and damage to many structures in the Cairo metropolitan area (population 12,000,000).

EERI dispatched a team of earthquake engineers and scientists to investigate the effects of this event. Team members were Nabih Youssef, structural engineer, Team Leader; Samy Adham, structural engineer; Mehmet Çelebi, USGS; and Josephine Malilay, Centers for Disease Control. The following report contains information from the preliminary report filed by the team.

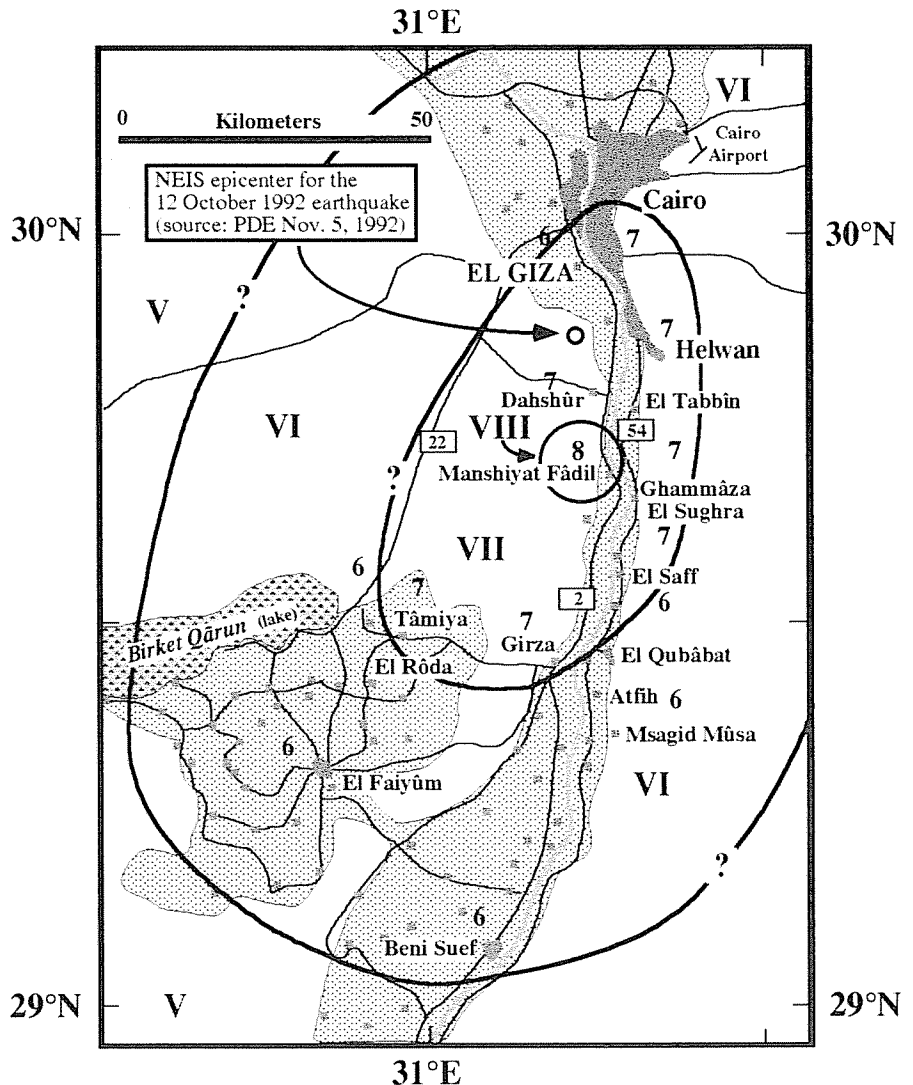
This preliminary isoseismal map is based on a four-day reconnaissance tour of damaged areas. The southern extent of the isoseismals is based on interviews with staff members of the Geological Survey of Egypt. The smoothed contours represent the highest predominant levels of Modified Mercalli Intensity (MMI) with regard to building damage, and do not preclude higher localized intensities and common lower intensities than the generalized level shown on the map. The western and eastern excursions of the isoseismals are depicted with a question mark to reflect uncertainty in their locations in desert regions characterized by very low population concentrations and little development.

In general, MMI VII effects were widespread in the villages of the Nile valley to approximately 80 km south of Cairo, which includes most of the populated area of the Giza governorship. Fallen adobe walls and collapsed roofs that had been supported by cross timbers were common. Brick-firing kilns with masonry smoke stacks approximately 20 m to 30 m tall are scattered throughout the Nile valley, but none was known to have toppled in the earthquake. This observation generally limits a maximum MMI assessment to a level lower than VIII for most of the affected area of the Nile valley. However, some maximum MMI VIII effects were observed in the village of Manshiyat-Fâdil, approximately 20 km south of the epicenter. The principal basis for this assessment was the fall of unreinforced masonry walls and more widespread damage to adobe buildings than in nearby villages.

Preliminary map of the Modified Mercalli Intensity distribution of the October 12, Cairo, Egypt earthquake.

Inspections in the city of Cairo were primarily in the southern and eastern parts of the city. Thus, the exact location of the VI-VII contour through the city is somewhat uncertain. Slight to moderate cracking in the walls of multi-story concrete-framed buildings was observed at scattered locations in south Cairo. The general degree of damage was taken to indicate a maximum predominant MMI of VII.
