Learning from Earthquakes

Western Sumatra Earthquakes of March 6, 2007

Report #1

Building Damage

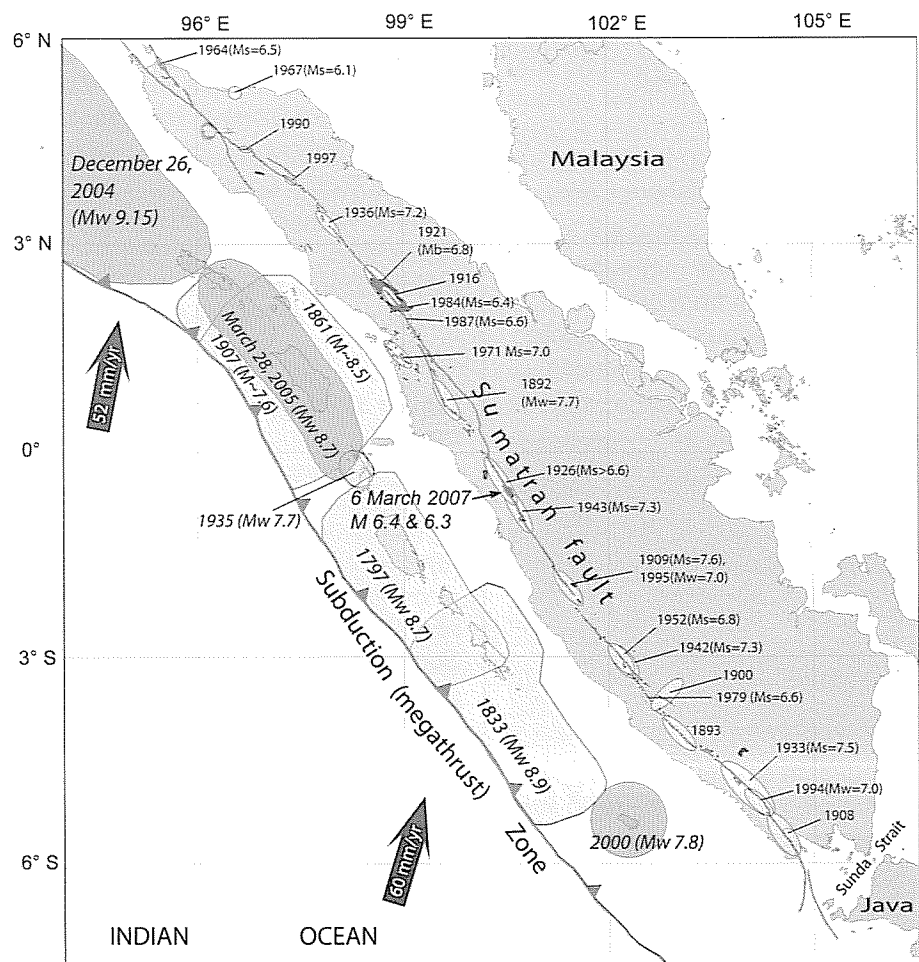
Figure 1. Historical major earthquakes along the Sumatran fault zone (SFZ) since 1892, including the 6 March 2007 event. The ellipsoid shapes indicate fault segments that were ruptured. The large ellipsoids west of Sumatra indicate recent and historical megathrust events in the Sumatra subduction zone.

Since 1890, there have been about 21 major earthquakes with magnitudes ranging from 6.5 to 7.7 (Figure 1). Thus, on average, there have been roughly two earthquakes every decade. In the past decade, two major earthquakes occurred in Liwa, south Sumatra in 1994 ($M_w 7.0$) and in the western flank of the Kerinci Volcano in 1995 ($M_w 7.1$). In the region of the recent March 6, 2007, earthquake, the historical earthquakes occurred in 1926 and 1943. Despite the frequency of large earthquakes, until now the threat has not been taken seriously in land use planning and building code practices.
