The November 15, 1994, M7.1 Mindoro Island Earthquake in the Philippines

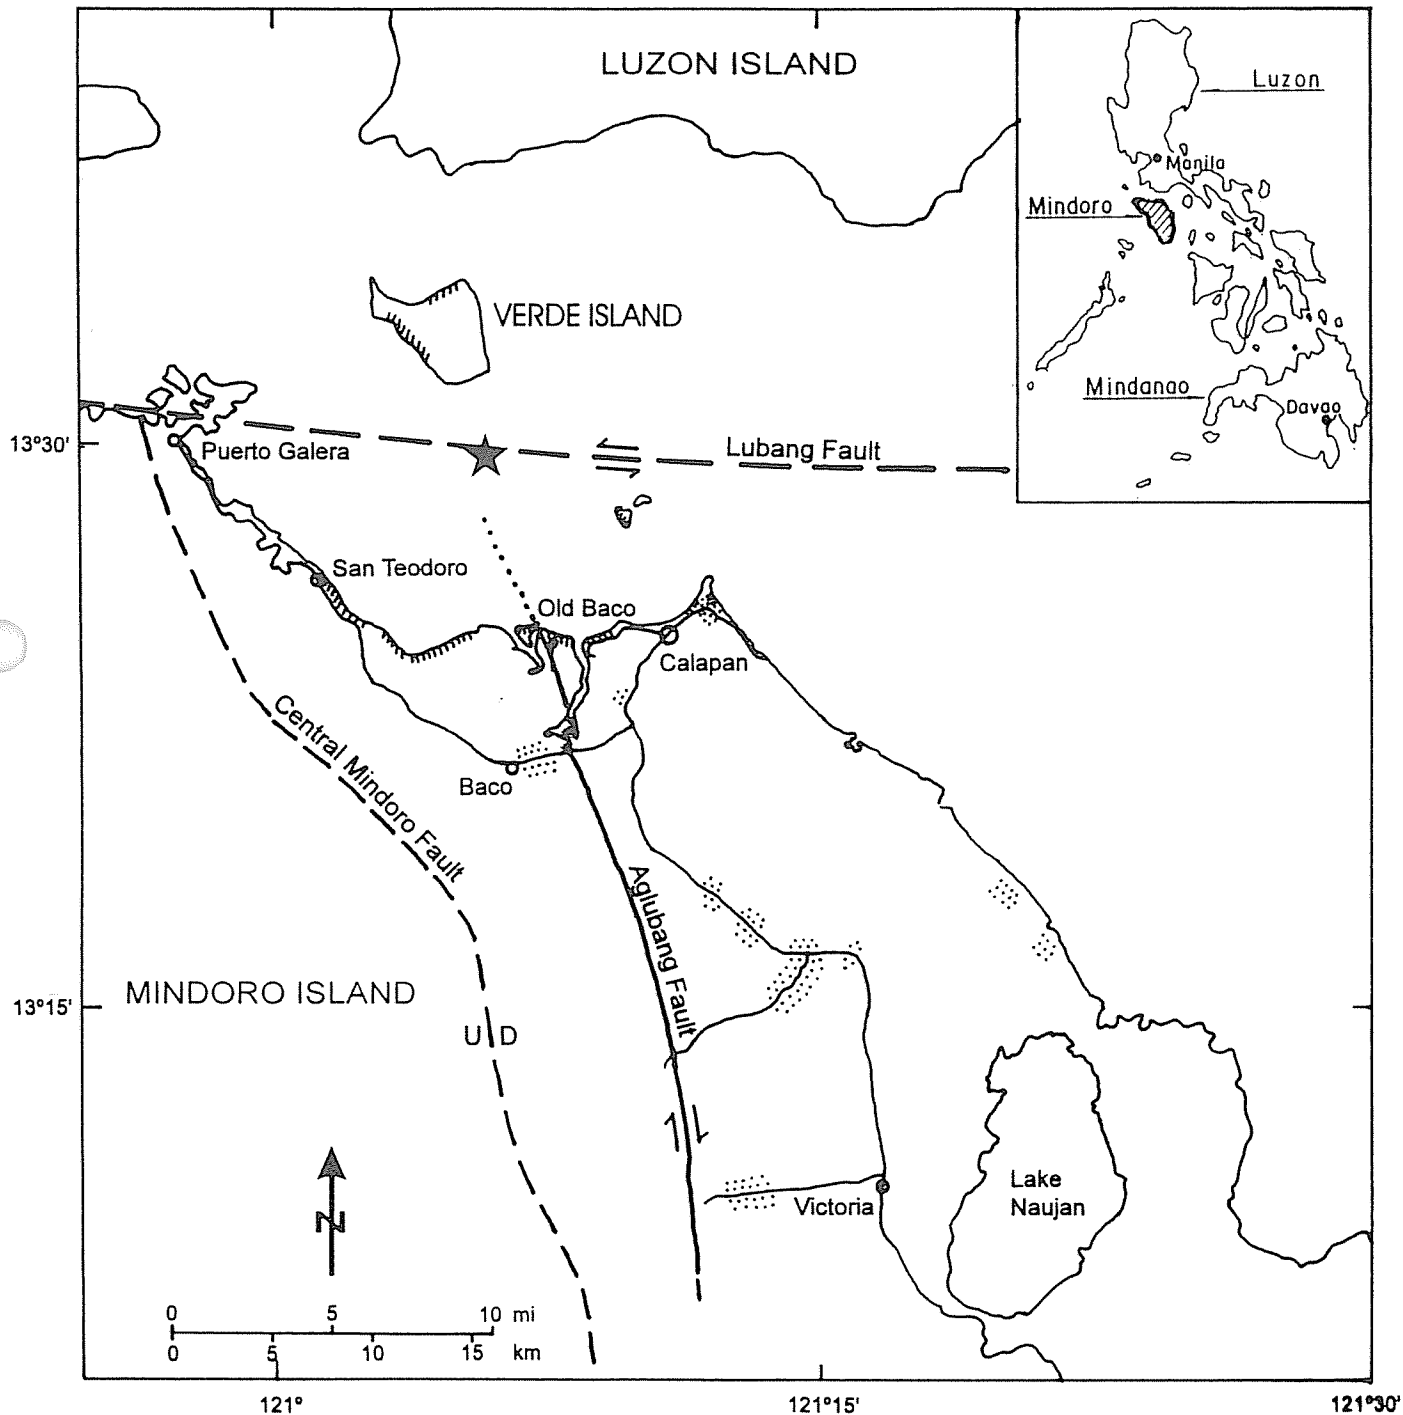
Figure 1—Map of northern Mindoro and southern Luzon islands showing location of surface rupture, liquefaction, and tsunami damage and other principal features associated with the earthquake. Stipple pattern shows location of liquefaction and lateral spreading, hachured pattern along coastline shows impact areas of tsunami, U—up, D—down on vertical slip faults, arrows show direction of movement of strike slip faults; star shows epicentral location of the M7.1 earthquake.
