Reconnaissance Report of Geotechnical Observations
for the 4 March 1977 Romanian Earthquake

T. L. Youd
U. S. Geological Survey
Menlo Park, California
Open File Report 77-375

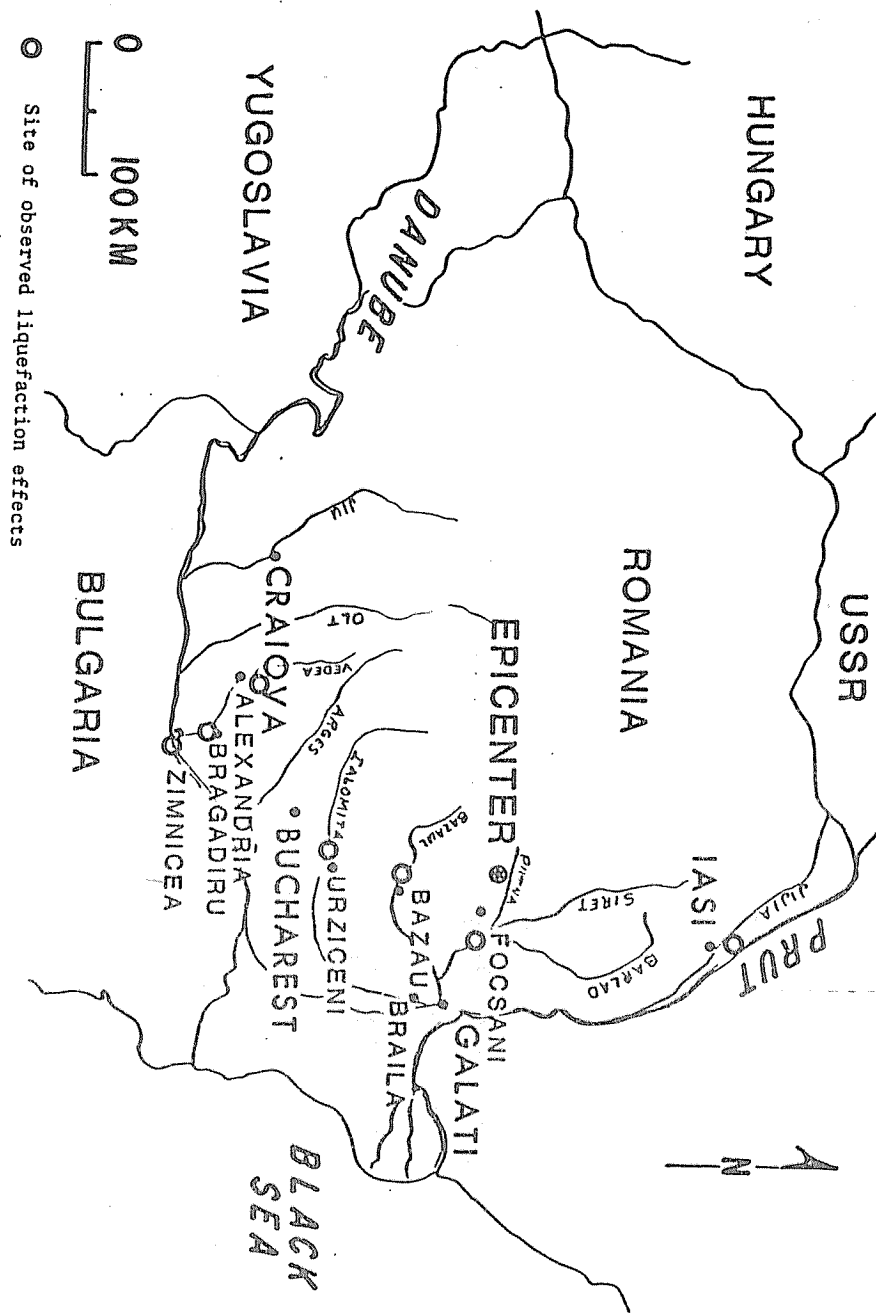
Fig. 1.--Map of Romania showing cities where major earthquake effects

have led to some significant damage, had they occurred in heavily populated areas. The localities at which liquefaction effects were observed are plotted on Fig. 1, and are described in the following paragraphs.
