Learning from Earthquakes

Preliminary Observations on the August 14, 2003, Lefkada Island (Western Greece) Earthquake

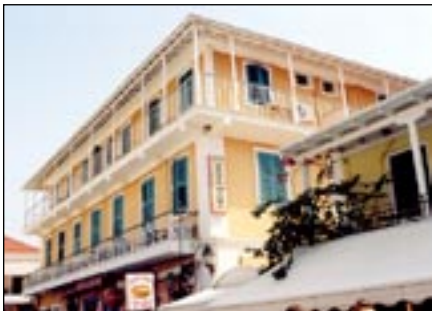
17a▲

Figures 17a, b, and c. The traditional earthquake-resistant system of Lefkada. The undamaged structure in Fig. 17a was built at the end of the 19th century. In Fig. 17b the wooden columns and beams (w) with wooden corners (c) are visible. In Fig. 17c the special earthquake system is shown under construction (NTUA-UoA team).

dual structural system (category B) behaved in a rather satisfactory way, given the intensity of the main event (ITSAK 2003). In this composite system, a wooden frame has special carved corners (figure 17) that strengthen beam-to-column joints, and wooden stiffening walls with x-braces. In the plane of these stiffening walls, various masonry materials may be added in order to increase the stiffeners and the energy absorbing capacity of the whole system. On the ground floor, the wooden frame comes in contact with the external masonry wall, with which it is well connected. The carved corners are also put in the lower part of the columns that are fixed to the foundation. In some cases, there was partial collapse of masonry walls (figure 18), but the structural stability of the building was ensured by the activation of the secondary (redundant) wood frame on the ground floor level.
