Learning from Earthquakes

The M_w 6.3 Java, Indonesia, Earthquake of May 27, 2006

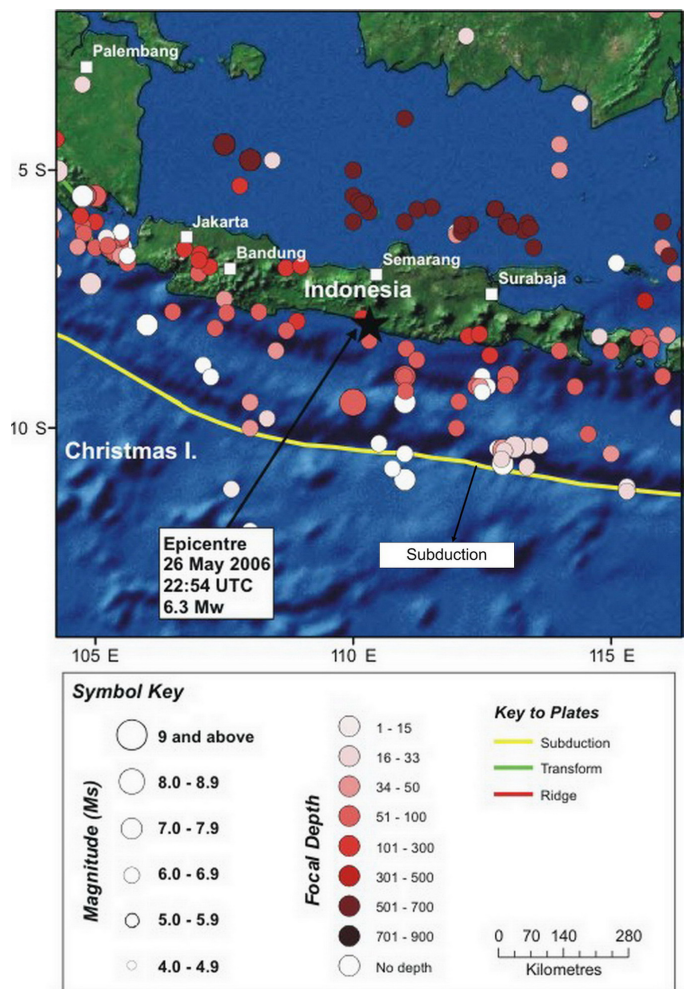
Figure 1 shows the seismicity of Java, which relates mostly to the subduction of the Australian plate under the Sunda plate (on which Java sits). However, it is thought that the earthquake was not due to subduction, but rather to

Figure 1. Seismicity map of Java, Indonesia (magnitudes above 6.0) since 1903 (British Geological Survey)

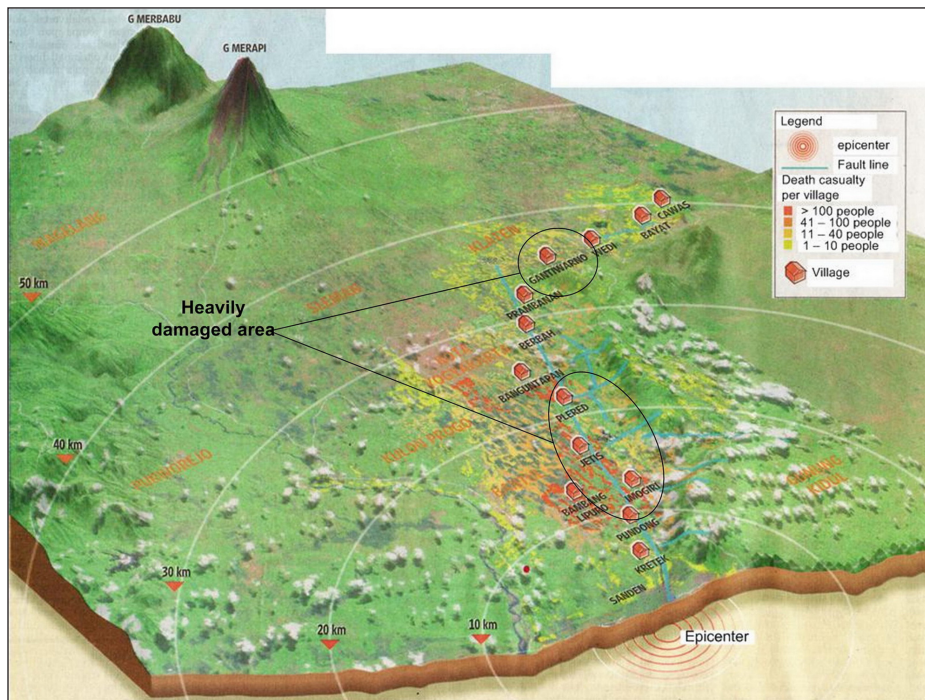
It was reported by a local newspaper (*Kompas* 2006) that the earthquake was caused by a rupture of the Opak fault; indeed, this correlates with the damage intensities in nearby villages (Figure 2). However, there is some debate among local seismologists and geologists about the location of the fault and the area of fault rupture.

Figure 2. Reported Opak fault and damage to nearby villages (Kompas 2006).

From a geotechnical perspective, the most pronounced effects of the earthquake are associated with directivity and soil amplification. Figure 2 shows the heavily damaged zones concentrated in two distinct areas: one near the epicenter (Imogiri, Bantul, Plered), and other further northeast (Gantiwar). It appears that directivity (and proximity to the fault rupture zone), topography, local site conditions, and the vulnerability of older unreinforced masonry homes (addressed later in this report) affected the severity of the damage. These effects, however, cannot be confirmed until the detailed study on

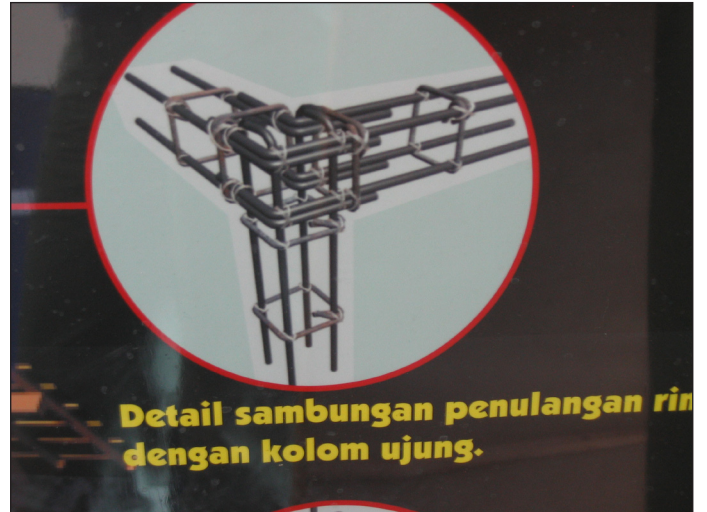
Figure 10. Beam column connection detailing in posters distributed by CEEDEDS.

Prior to the earthquake, three houses were built in Wonokromo, Pleret (Bantul) under the supervision and direction of Professor Sarwidi of the Center for Earthquake Engineering, Dynamic Effect, and Disaster Studies (CEEDEDS) at Universitas Islam Indonesia. These confined masonry houses used connection detailing shown in the posters distributed by CEEDEDS (Figure 10). The houses performed very well in the earth-

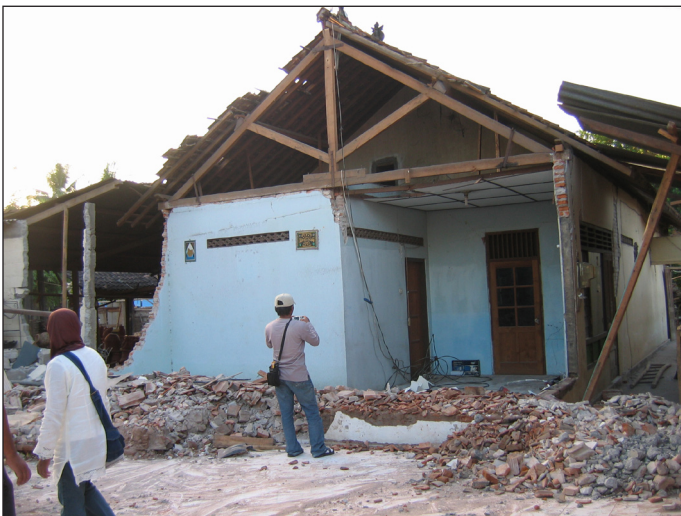
beams were generally 8 cm by 12 cm and made from coconut trees, local hardwood, or hardwood from Kalimantan. Bamboo is also common for roof structures. Some older houses were a mix of structural systems, in which part of the roof load was carried by timber posts infilled with masonry. A typical timber truss is shown in Figure 14.

Figure 14. Typical timber truss with steel plates reinforcing the joints, Kasongan, Kasihan (Bantul) ($S7.84512^{\circ}$ $E110.33534^{\circ}$).

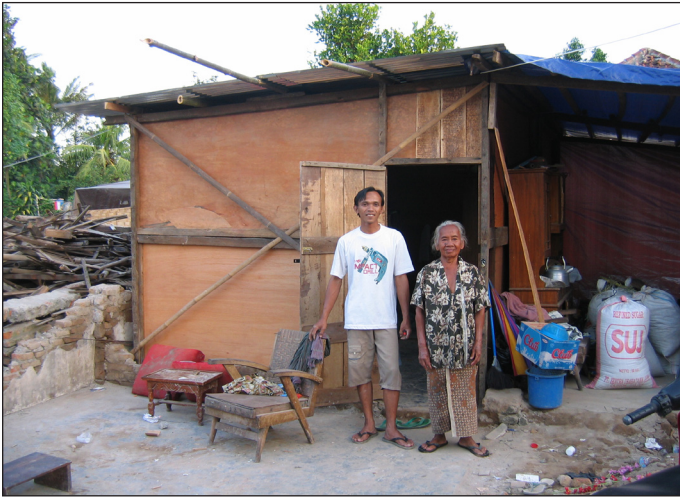
Figure 16. Transitional house in Pleret (Bantul) ($S7.83686^{\circ}$ $E110.41552^{\circ}$).

Housing Reconstruction: Tents were distributed in some areas, as were hammers, shovels and other tools to support debris clearing and recycling. Many families with destroyed houses had already rebuilt transitional one- or two-room shelters on the foundation of their destroyed houses (Figure 16). Transitional shelters use a mix of recycled timber, bamboo, and window and door frames, and new plastic tarps, plywood and corrugated galvanized iron sheets. Also, many families were continuing to live in houses that were damaged beyond repair and vulnerable to collapse in aftershocks.
