## Learning from Earthquakes

# Preliminary Observations on the Al Hoceima, Morocco, Earthquake of February 24, 2004

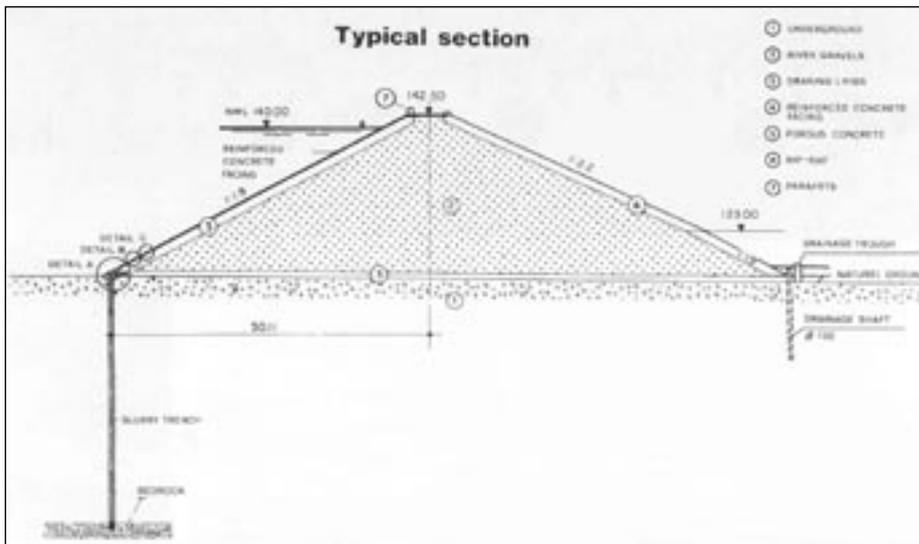
The only earthquake-related effects noted were two small transverse cracks in the asphalt-paved roadway surface on the crest of the dam. The southerly crack was approximately above the contact between the eastern edge of a buried concrete slab in the spillway structure and above the southern contact between bedrock on which the spillway structure is founded and the valley alluvium on which most of the embankment section is founded. The northern transverse crack was similarly located approximately above the contact between valley alluvium and bedrock contact beneath the northern

part of the embankment. Neither crack was wider than a few millimeters. The cracks were caused either by differential response of the embankment to ground shaking, or by slight settlement within the valley alluvium or possibly within the embankment. A re-survey of benchmarks on the crest of the dam indicates that as much as 10 mm of settlement occurred between the two cracks during the earthquake. The cracks were assessed as superficial and insignificant with respect to the performance and safety of the dam.

**Figure 5** Typical cross section of embankment segment of the El Khattabi dam (Moroccan Ministry of Equipment drawing).
