## Learning from Earthquakes

# Preliminary Observations on the Southern Peru Earthquake of June 23, 2001

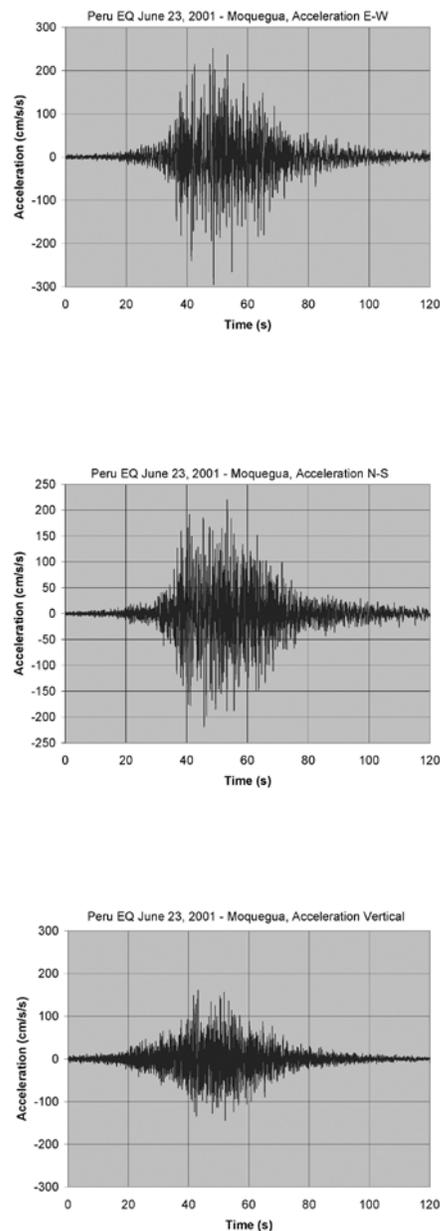
**Figure 2** Acceleration time histories of the east-west, north-south, and vertical components of the corrected ground-motion recording in the city of Moquegua. (The Universidad Nacional de Ingenieria and the Centro Peruano Japonés de Investigaciones Sísmicas y Mitigación de Desastres [CISMID]).

**Moquegua:** Moquegua was the city hardest-hit by this earthquake. The records (see Figure 2) indicate that the peak ground acceleration was 0.30g and the response spectra had a plateau at approximately 0.65g-0.70g in the range from about 0.15 seconds to 1 second (see Figure 3). The damage in Moquegua is mainly to old and new adobe houses. Numerous adobe buildings collapsed in the downtown area, and many others sustained heavy damage to the point of being almost unstable. In the area of San Francisco, the hillside was nearly totaled due to collapse of new adobe houses. One school had a partial collapse due to short columns (Figures 9 and 10). The cathedral lost one of its vaults, and the Church of Belen sustained damage to its tower and walls.

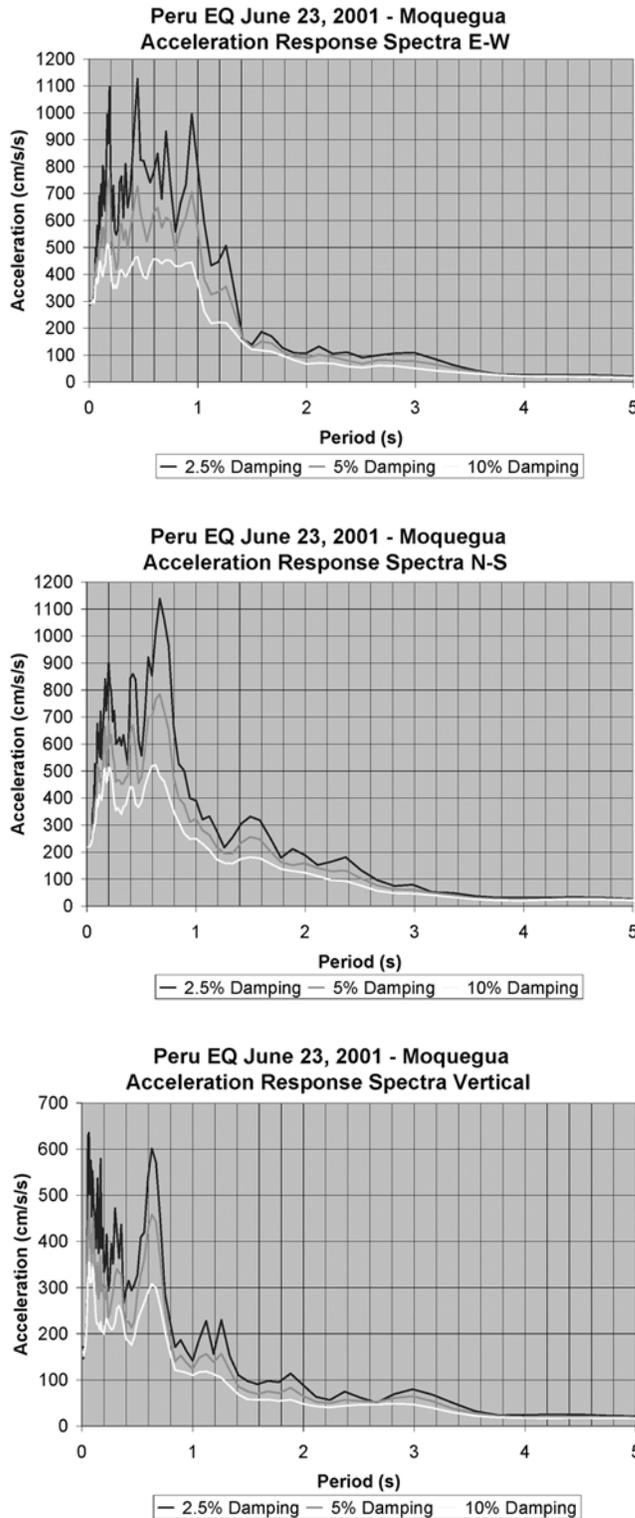
**Figure 3** Acceleration response spectra obtained from the corrected ground motion along the east-west, north-south, and vertical components of the recording in the city of Moquegua. (The Universidad Nacional de Ingenieria and the Centro Peruano Japonés de Investigaciones Sísmicas y Mitigación de Desastres [CISMID])

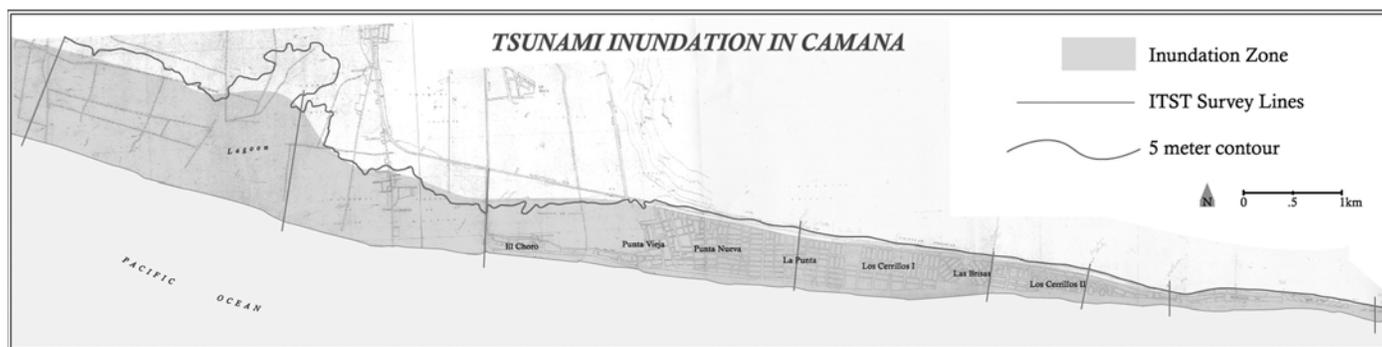
significant than the tsunami effects. The largest waves (5-8 m) and deepest penetration (1-1.2 km) (Figure 7) produced by this tsunami coincided with the most-developed beach resort area along the southern Peruvian coast. La Punta and the adjacent resort communities have many summer homes, occupied by about 5000 residents during the peak summer season.

**Figure 7** Tsunami inundation and ITST survey lines in the Camana area. (Base map from the Planning Department of the Municipalidad Provincial de Camana, inundation by L. Dengler based on ITST data. Map compiled by Verena Kellner, Humboldt State University.)
