Napa M5.2 Earthquake of September 3, 2000

Evaluation of Lifeline Performance

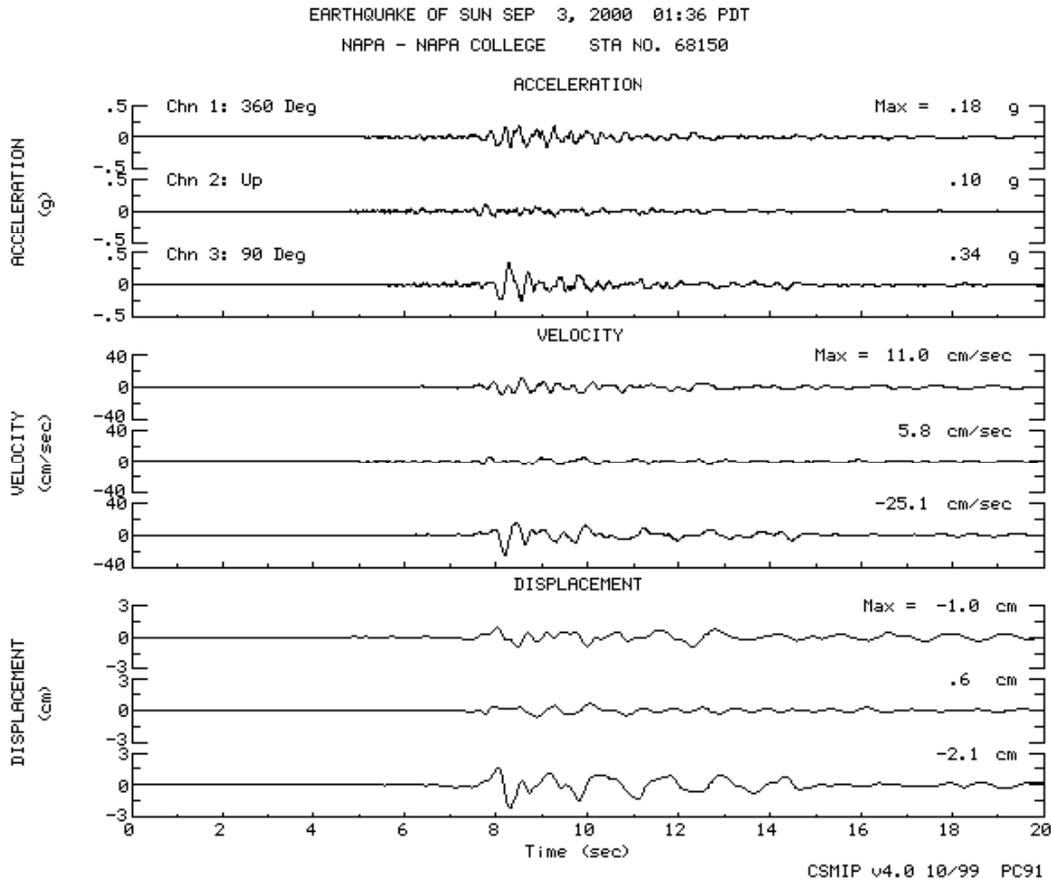
Figure 2. Recorded Ground Motions - CSMIP Station 68150

Figure 2 shows the ground motion time histories for instrument 68150. The motions suggest a site period of about 0.4 seconds, typical of a deep alluvial site. In fact, the instrument is located at Napa Junior College, just east of the Napa River.
