RECONNAISSANCE REPORT: YOUNTVILLE/NAPA, CALIFORNIA EARTHQUAKE

Submitted by Kevin Moore, Kent Yu, Ron LaPlante
Degenkolb Engineers – Oakland, San Francisco

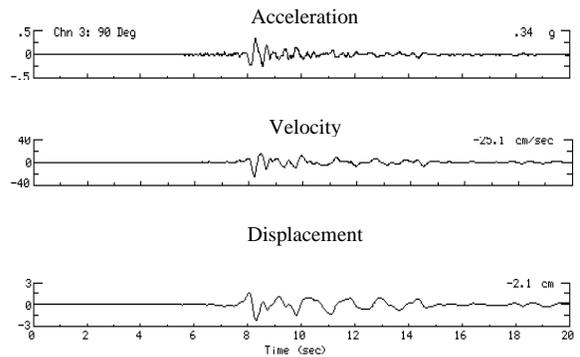
Figure 2a - Strong motion records measured at Napa Valley College Instrument Station (E-W)

Division of Mines and Geology Strong Motion Instrumentation Program (CSMIP) are within 30 miles of the epicenter. One instrument, located in a maintenance shed on the Napa Valley College campus (approximately 8 miles south of the epicenter), recorded the most intense record as shown in Figures 2a and 2b. The instrument site is located in an area of soft soil, which explains the high peak ground acceleration.

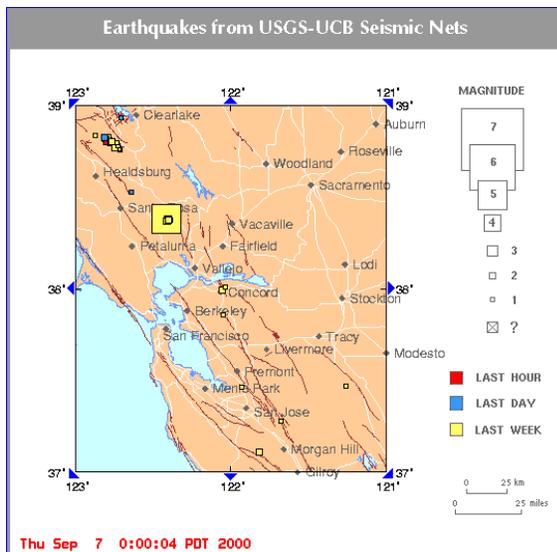
The Yountville/Napa Earthquake occurred on September 3, 2000 at 1:36 a.m. Pacific Standard Time. The epicenter ($38^{\circ}22.6'N$; $122^{\circ}24.8'W$) was about 2.5 miles west of Yountville, 7 miles northwest of Napa, and 17 miles east of Santa Rosa at a focal depth of approximately 6 miles. The local Richter magnitude was $M_L=5.2$ and the local moment magnitude was $M_w = 5.0$. Loss estimates range from 15 to 70 million dollars. The earthquake is reported to have occurred on a previously unknown fault with a right-lateral strike-slip mechanism. The majority of strong shaking was felt south of the epicenter with most significant ground motion reported in the city of Napa. Reports of shaking ranged as far east as Sacramento with no reports of shaking further north than St. Helena, indicating a possible directivity to the south of the epicenter. Figure 1 shows the earthquake and aftershock intensity data collected by USGS.

Figure 1 - Map of the Bay Area and the Yountville/Napa Earthquake, and aftershocks [1]
