## PRELIMINARY REPORT ON SEPTEMBER 28, 2004 PARKFIELD EARTHQUAKE

Rakesh K. Goel, M.EERI and Charles B. Chadwell, M. EERI  
Department of Civil & Environmental Engineering,  
California Polytechnic State University, San Luis Obispo, CA 93407  
Email: [rgoel@calpoly.edu](mailto:rgoel@calpoly.edu), [chadwell@calpoly.edu](mailto:chadwell@calpoly.edu)

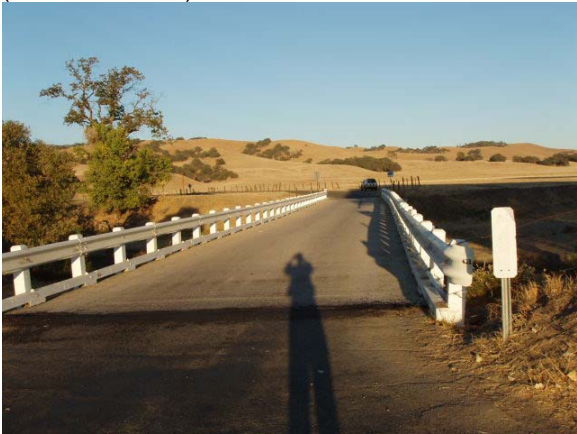
The second bridge investigated is located at the intersection of Cholame Road and Parkfield-Coalinga Road (Figure 8) in Parkfield and crosses the San Andreas Fault (Figure 21). This bridge had apparently undergone a recent retrofit and performed adequately. The minor distress to the bridge included roughly 4 cm separation between the approach slab and the bridge deck, which was filled up quickly by the bridge maintenance crew (Figure 22). Below the deck level, the concrete bent caps had minor shear cracking through the knee joints (Figure 23 and 24) as well as evidence of the flexural cracking at the top of the pile extension (Figure 25). The pile extensions at the ground level also exhibited noticeable movement (Figure 26). In addition, there was evidence of recent motion (approximately 4 cm) in the bridge bearings supporting the superstructure. Angle iron apparently installed in an effort to restrain transverse motion of the superstructure at the bearings was knocked free (Figures 27 and 28).

Figure 21. Bridge crossing the San Andreas Fault (Photo: Goel).
