Learning from Earthquakes

Preliminary Observations on the November 3, 2002 Denali Fault, Alaska, Earthquake

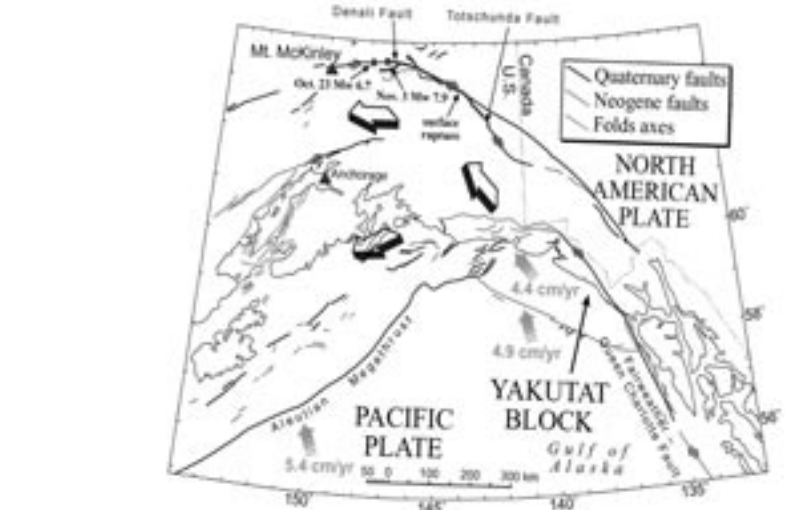
Figure 2 - Neotectonic Setting of Southeastern Alaska

sion of the Yakutat terrain into the cusp of southern Alaska (figure 2). The Yakutat terrain is a crustal fragment that used to lie offshore between southeastern Alaska and southern Vancouver Island. Around 25 to 30 million years ago, it began to collide with the continental margin, resulting in uplift of the eastern Chugach-Saint Elias Mountains. The Yakutat terrain is moving at 4.4 cm per year toward an azimuth of 323°, and the Pacific plate is moving beneath southern Alaska at a rate of 4.9 cm per year toward an azimuth of 349°. These velocities are similar, but the azimuths are significantly different. As a result of the collision, parts of southern Alaska are being extruded to the west and southwest.
