Learning from Earthquakes

Preliminary Observations on the November 3, 2002 Denali Fault, Alaska, Earthquake

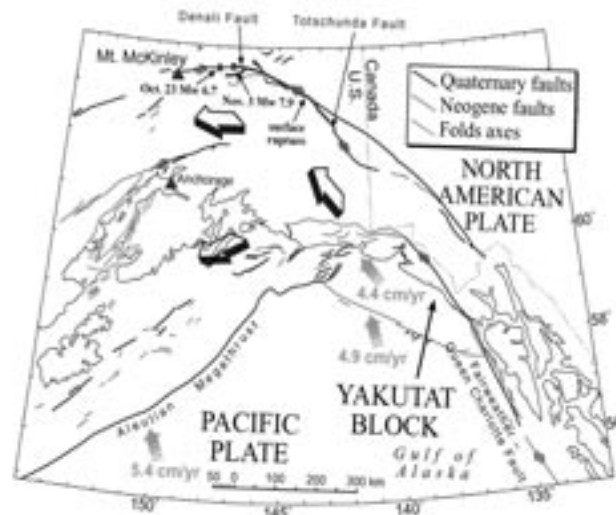
Figure 2 - Neotectonic Setting of Southeastern Alaska

sion of the Yakutat terrain into the cusp of southern Alaska (figure 2). The Yakutat terrain is a crustal fragment that used to lie offshore between southeastern Alaska and southern Vancouver Island. Around 25 to 30 million years ago, it began to collide with the continental margin, resulting in uplift of the eastern Chugach-Saint Elias Mountains. The Yakutat terrain is moving at 4.4 cm per year toward an azimuth of 323°, and the Pacific plate is moving beneath southern Alaska at a rate of 4.9 cm per year toward an azimuth of 349°. These velocities are similar, but the azimuths are significantly different. As a result of the collision, parts of southern Alaska are being extruded to the west and southwest.

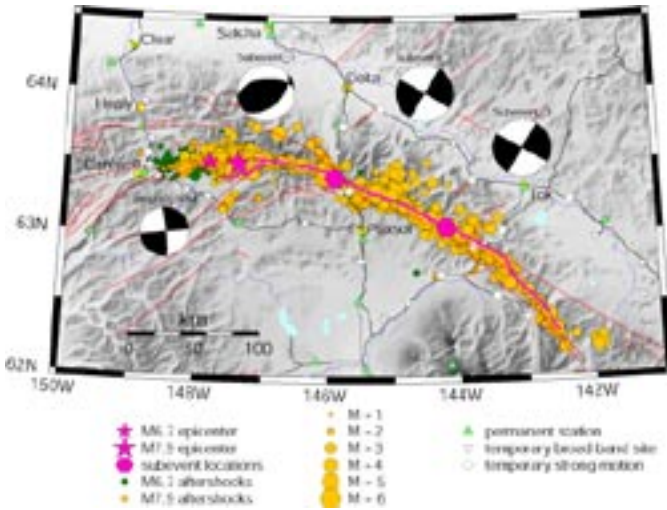
Figure 5 -
Seismicity map of Alaska

ber 23 by the Mw 6.7 Nenana Mountain earthquake. This event was also located on the Denali fault, 22 km west of the epicenter of the November 3 earthquake. It was also a right-lateral strike-slip earthquake, but there was no surface rupture. The November 3 earthquake began with a ~M7.2 thrust event at the epicenter. Rupture then progressed for about 100 seconds from west to east along the Denali fault, and then turned onto the Totschunda fault (figure 5).

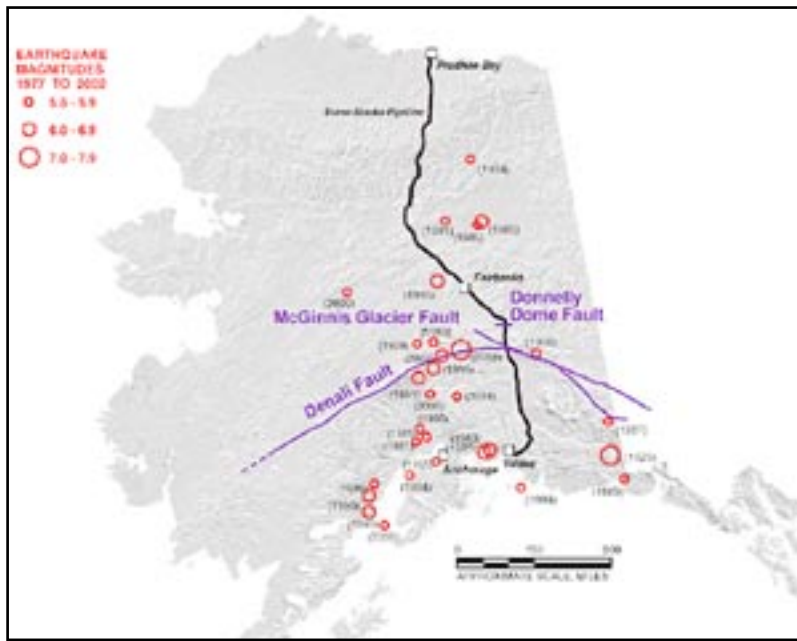
Figure 10 - TAPS pipeline alignment

The Denali fault intersects the pipeline as it passes through the Alaska Mountain Range at milepost (MP) 588 (from Prudhoe Bay) in the vicinity of its Pump Station Number 10 (figure 10). There were maximum ground accelerations of about 0.35g and ground velocities of about 45 inches per second recorded along the pipeline right-of-way about 3 km north of where the pipe crosses the fault. The horizontal fault rupture offset was nearly 3 m at the fault trace, with a total displacement of about 4 m distributed across the fault zone. A 0.5 m downward displacement of the south fault block was also noted at the pipeline fault crossing. Maximum horizontal surface fault displacements were nearly 9 m at a location approximately 120 km southeast of the pipeline crossing.

The pipeline withstood the fault rupture and associated ground shaking with

dam-age to the pipe
 e oil,
 s inci-dental damage to
 d sup-port hardware.
 was shut down for 66
 ections and repairs.
 umber
 ing sup-
 ports was required to
 restore the fault movement capacity
 to an additional 2 m strike slip,

which accommodates estimates of fault displacements that can reasonably be expected in the short term if further activity occurs on the fault.
