Learning from Earthquakes

The M_w 7.2 El Mayor Cucapah (Baja California) Earthquake of April 4, 2010

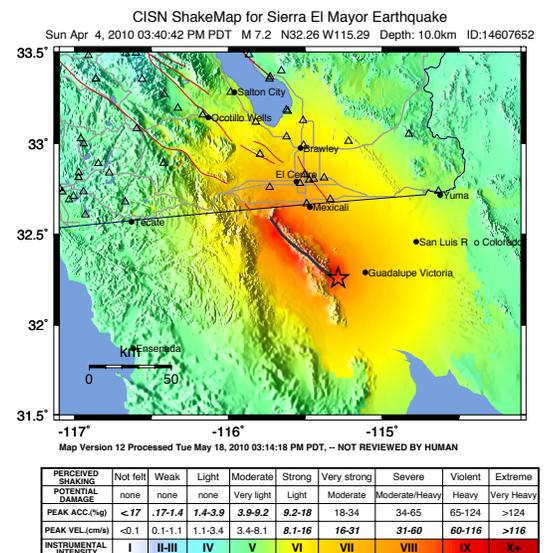
Figure 1. Distribution of intensities. Star shows location of epicenter (<http://earthquake.usgs.gov/earthquakes/eqinthenews/2010/ci14607652/#maps>).

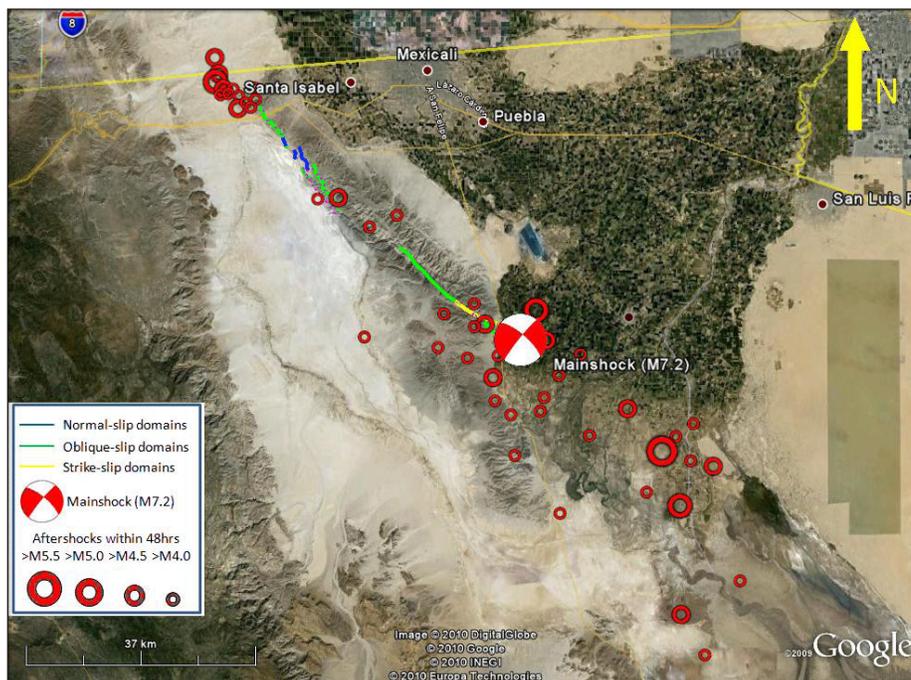
Surface rupture extends about 100 km from the northern tip of the Gulf of California to the international border and comprises two distinct geomorphologic and structural domains. As shown in Figure 2, the rupture is complex, with breaks along multiple fault strands, including minor re-rupture of the scarps associated with the 1892 Laguna Salada earthquake and several other older events. The southern part of the rupture consists of a zone of distributed fracturing and liquefaction that cuts across the Colorado River delta. Individual fractures vary widely in orientation and have relatively short strike lengths of as small as hundredths of meters. The zone itself may be related to faults that bound the eastern margin of the Sierra El Mayor, but field relationships are unclear, and the zone of more intense fracturing diverges significantly from the mountain front toward the south.

Figure 2. View of earthquake region showing location of mainshock hypocenter, aftershocks in first 48 hours, and mapped locations of surface rupture (moment tensor and aftershock locations from SCSN web site: <http://www.scsn.org/2010sierraelmayor.html>).

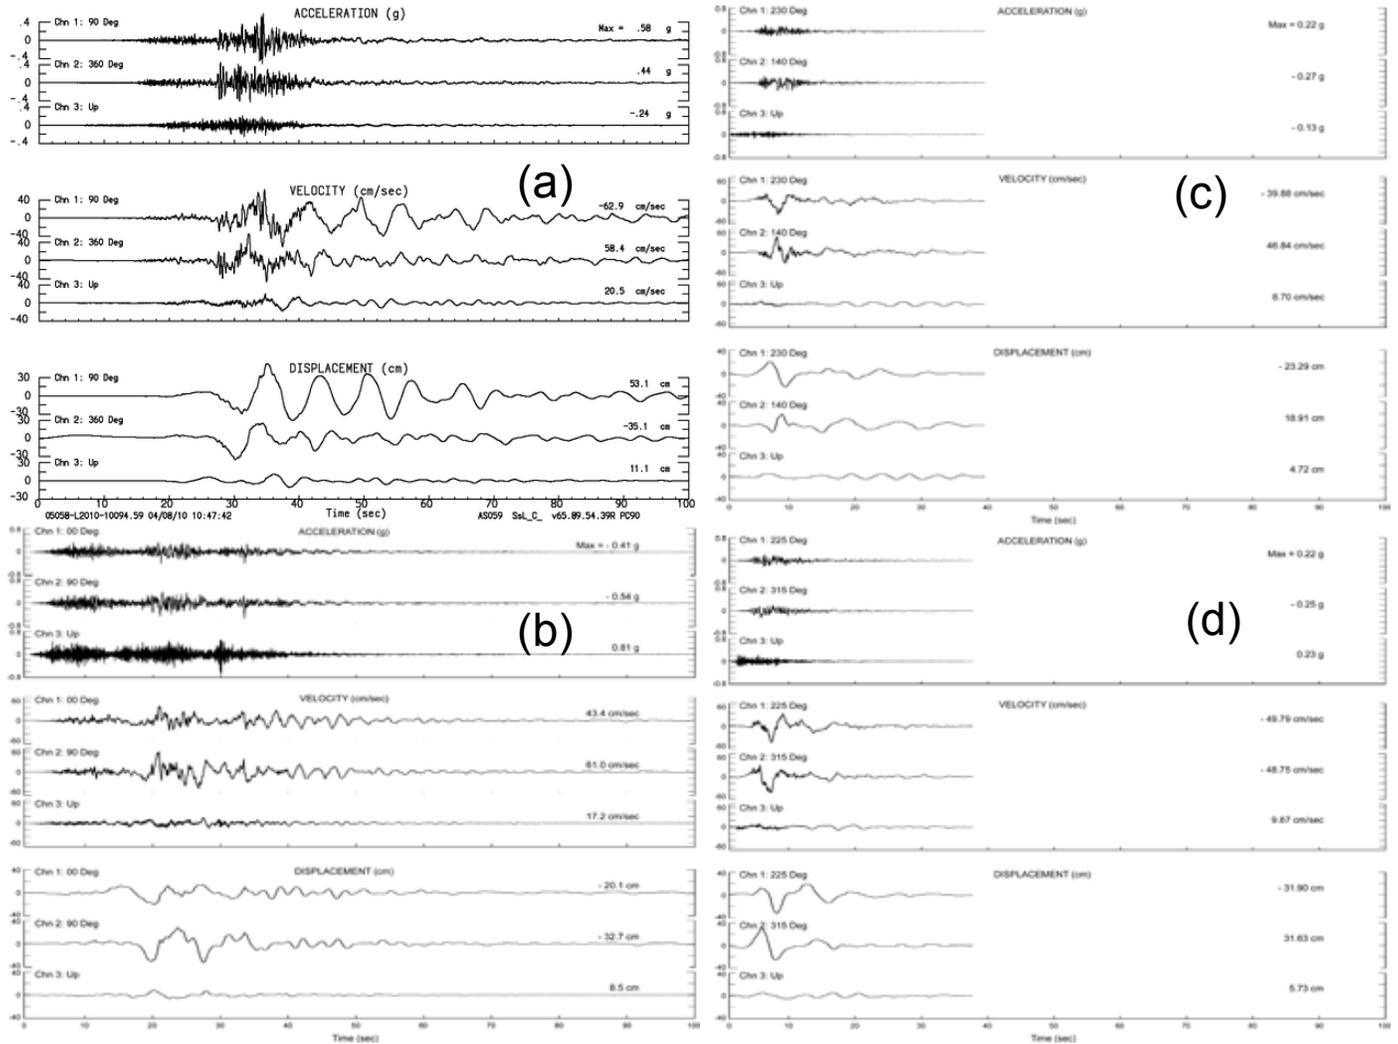
Figure 4a presents the acceleration, velocity, and displacement time histories of the main event recorded at El Centro — Array 11, McCabe School. The PGD and PGV were 53.1 cm and 62.9 cm/sec respectively. Figure 4b presents the acceleration, velocity, and displacement time histories of the main event recorded at MDO station, Baja California. The peak displacement (PGD) and velocity (PGV) for the E-W component were calculated at

The ground motions recorded at MDO and El Centro 11 stations bear many similarities to recordings from two stations located at almost identical locations on the Imperial Fault during the 1979 Imperial Valley earthquake — the Holtville Post Office (Figure 4c) and El Centro Array 3 (Figure 4d) (Singh 1985).

Figure 4. Ground motions recorded during the 2010 and 1979 earthquakes (a) El Centro Array 11, McCabe School, 2010, California; (b) MDO Station, 2010, Baja California, México; (c) Holtville Post Office, 1979, California; and (d) El Centro Array Station 3, 1979, California.

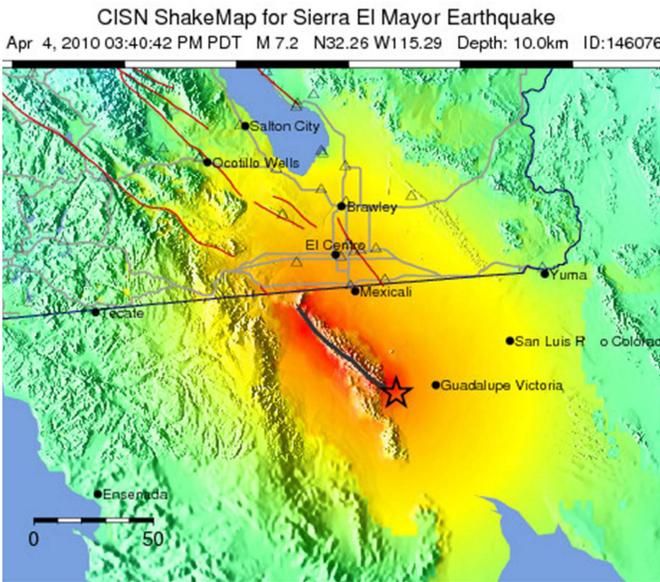
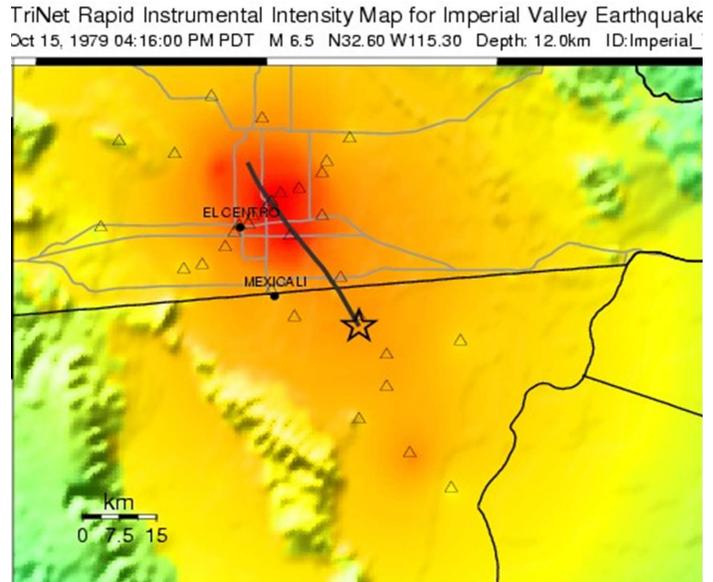
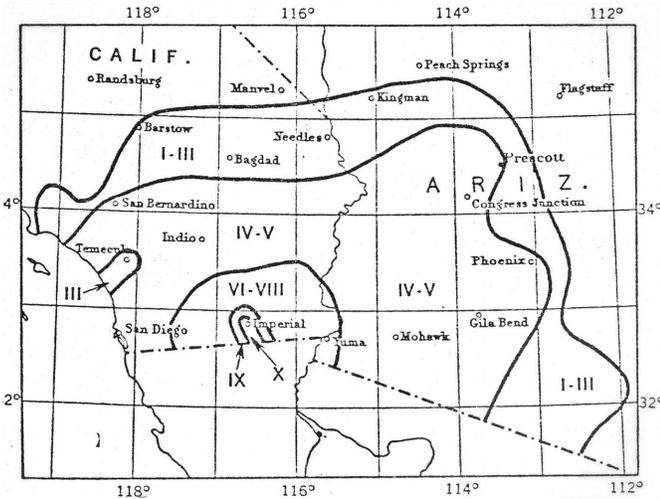
Figure 20. Ground shaking intensity maps from three significant earthquakes in the region: above left 2010; above right 1979; bottom left 1940.

over a series of faults southwest of Mexicali, with a strike similar in orientation to the Imperial fault. ShakeMaps from the 2010 and 1979 earthquakes and an isoseismal map for the 1940 earthquake (north of the border) are provided in Figure 20.
