Learning from Earthquakes

The M_w 7.0 Haiti Earthquake of January 12, 2010: Report #2

This second insert on the Haiti earthquake covers engineering failures and the social impacts of the quake. The first report in the April issue covered seismology and geotechnical aspects, primarily. The EERI team responsible for this report, including members from partnering organizations — the Network for Earthquake Engineering Simulation, the Mid-America Earthquake Center, Florida International University, Sherbrooke University, University of Delaware's Disaster Research Center and Western Washington University's Resilience Institute — visited Haiti from February 28 through March 7, 2010. The 18-member multi-disciplinary team included engineers, social scientists, city planners, architects, and geographers. The EERI team worked with the ASCE Technical Council on Lifeline Earthquake Engineering team and, together, the teams visited over 500 facilities and buildings in the heavily hit areas of Port-au-Prince, Léogâne, Petit Goâve, and Jacmel. The EERI team and its partners consisted of Reginald DesRoches, Georgia Institute of Technology (team leader); Susan Brink, University of Delaware; Peter

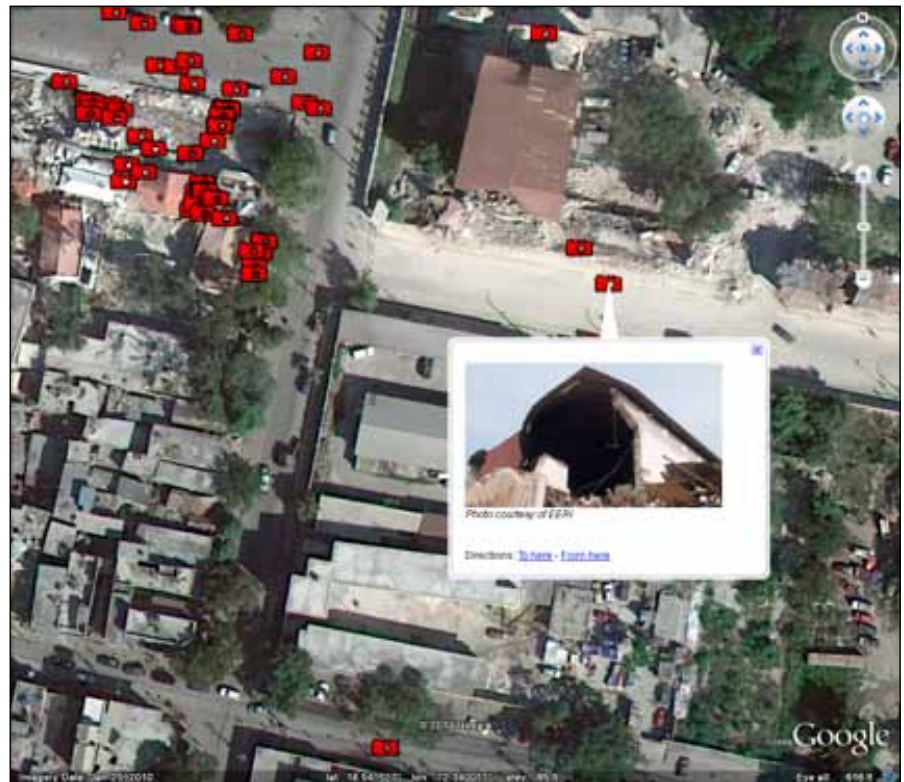
Figure 1. Georeferenced digital photos taken by the reconnaissance team or donated to EERI are available in KML format at http://www.virtualdisasterviewer.com/vdv/download_photo_kml.php?eventid=7.

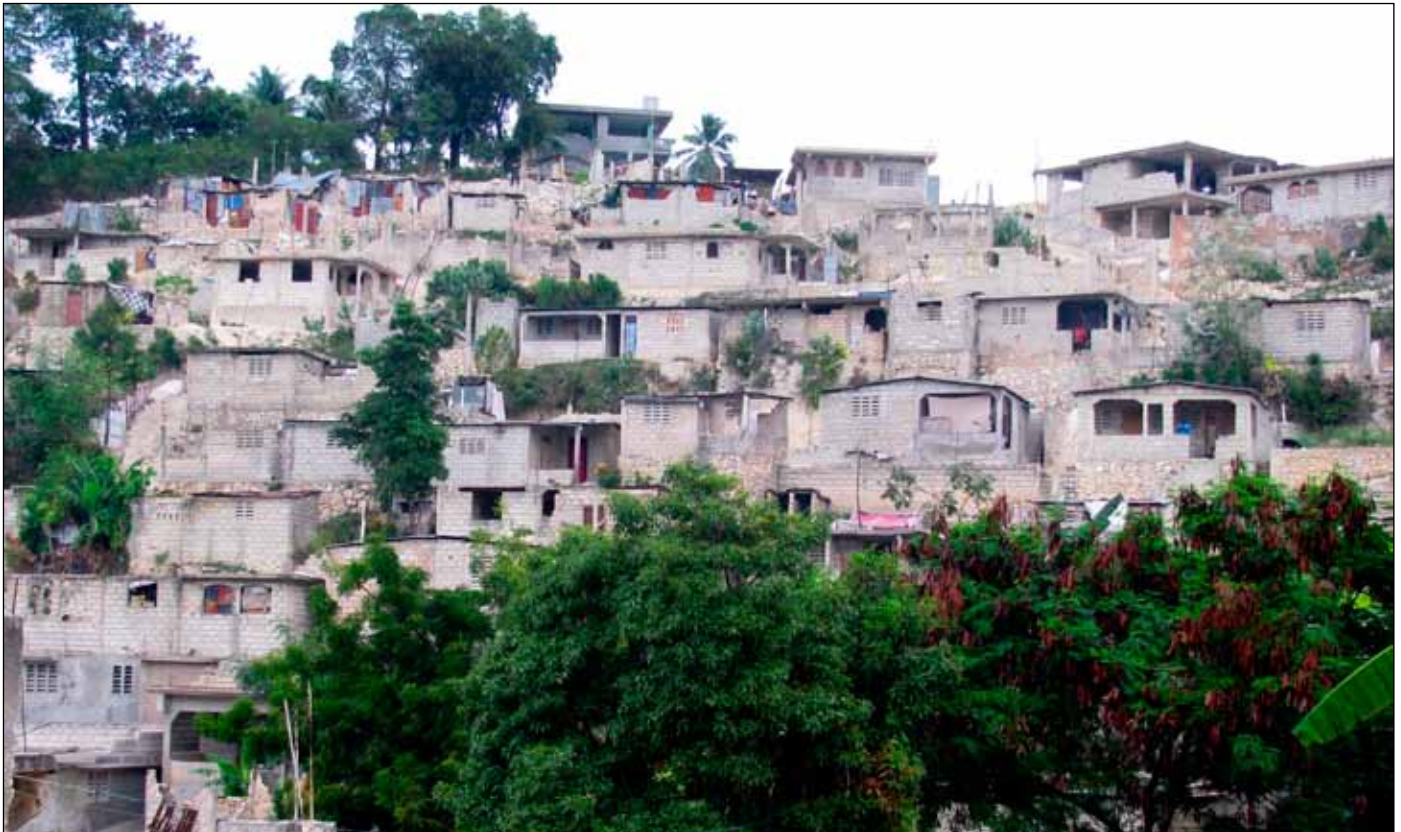
Many residences are constructed over a significant length of time as the homeowner acquires funds or the family's needs expand. Most are designed and constructed by the owner or a local mason. Residents sometimes squat on land, public or private, to be near family, friends, or their employment. These unauthorized developments, known by the French term *bidonville*, are found on hillsides surrounding Port au Prince and Petionville, as well as in low-lying coastal areas such as Cite Soleil (Figure 11).

Figure 11. Typical residential bidonville in the hillsides above Port-au-Prince (photo: Anna Lang).

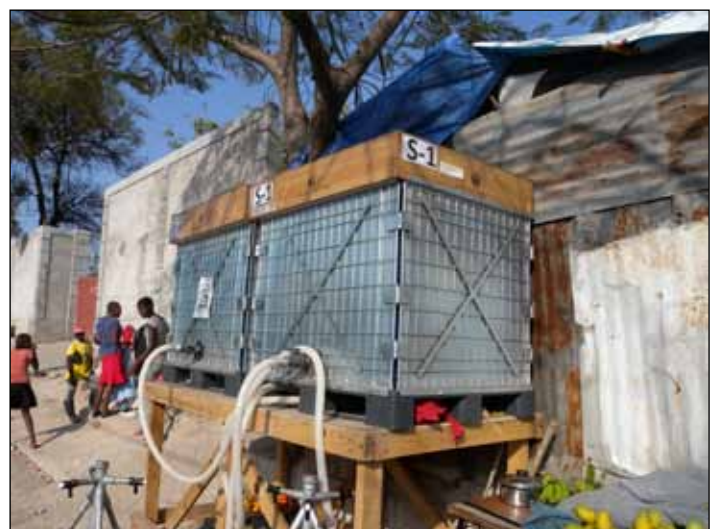
Figure 17. Emergency water tank (photo: Rebekah Green).

sponse organizations and NGOs had set up portable treatment equipment at selected locations and were treating water drawn from the public water system. A German group set up a major temporary treatment facility near the airport, and distributed potable water by tank trucks supplied by the local contractors. Starting on January 19, water was being distributed to 500 sites that had plastic tanks and bladders (Figure 17).

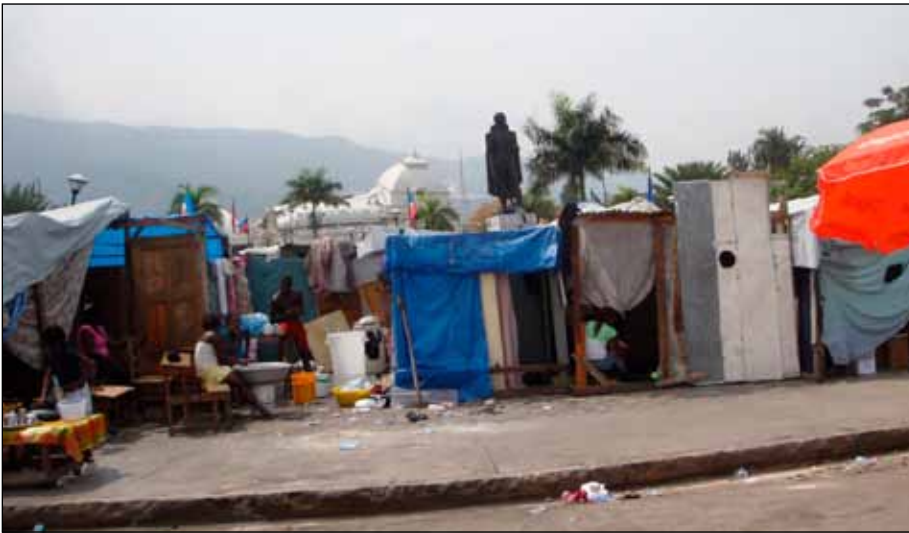
Figure 21. Champ de Mars IDP camp near the Presidential Palace (background) in downtown Port-au-Prince (photo: Rob Olshansky).

homes (Figure 20). Most IDP camps were created spontaneously by individuals, with subsequent water, food, sanitation, and shelter support from NGOs (Figure 21). Many in the Port-au-Prince metro area are still without weather-resistant shelters.

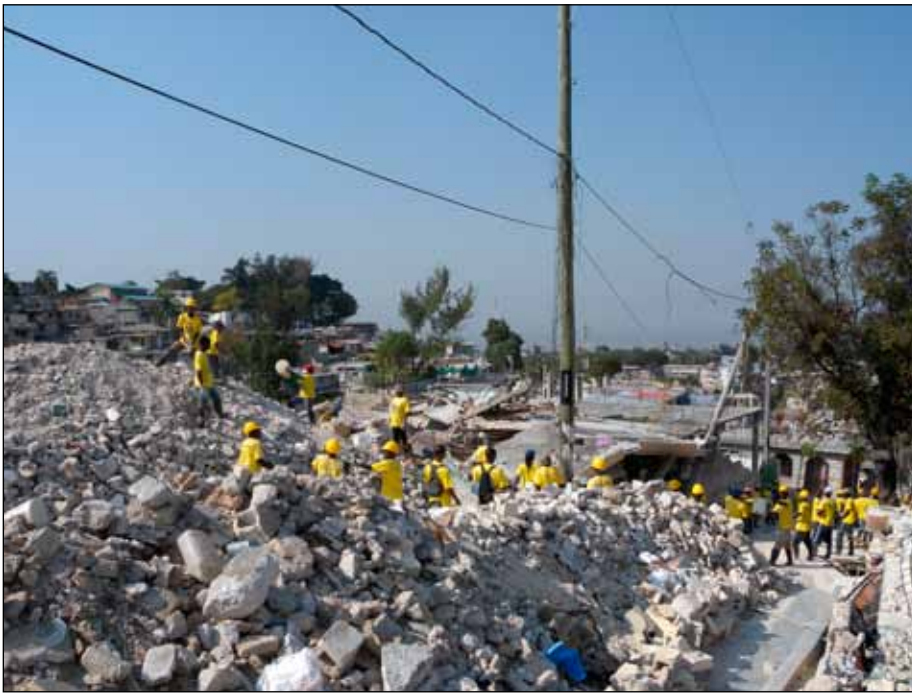
Figure 24. Cash-for-work for clearing debris from neighborhood school in the Nerette neighborhood of Petionville (photo: Rebekah Green).

Debris removal and management: The Early Recovery Cluster is actively planning and implementing a plan for debris removal, with a current focus on roads and drainage ditch clearance. However, the amount of debris exceeds available resources for removal (Figures 24 and 25). The availability of heavy equipment is extremely limited in Haiti, with only two Haitian government agencies operating it; private sector equipment is very expensive. Foreign militaries provided heavy equipment for early debris removal (Figure 26), but many are now pulling out of Haiti. Although some heavy equipment is being donated locally and internationally, the problem of disposal remains.

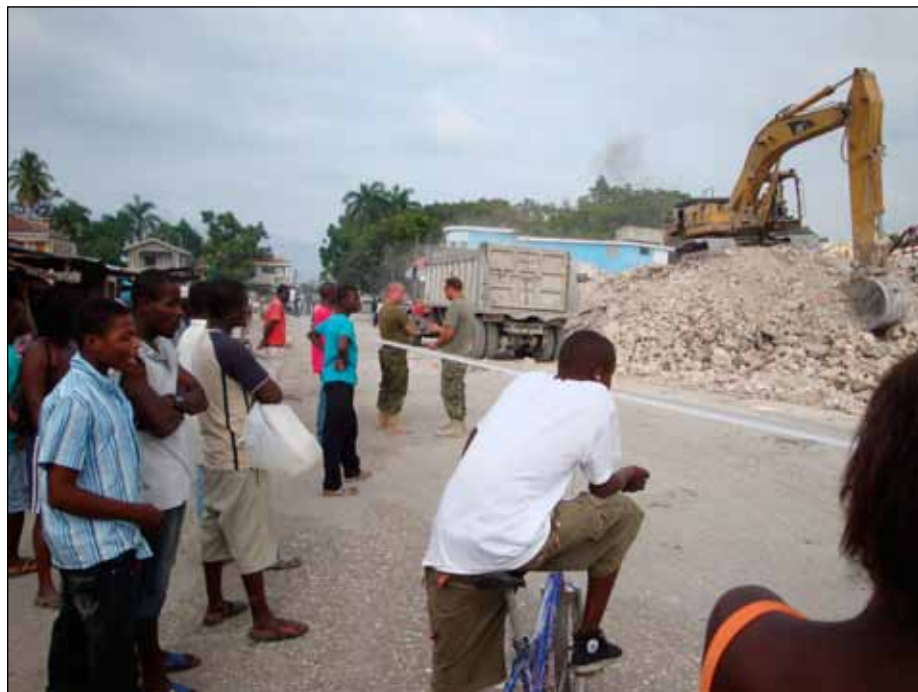
Figure 26. Canadian forces clearing debris of church in the town square of Léogâne (photo: Rob Olshansky).
