Learning from Earthquakes

The M_w 7.0 Haiti Earthquake of January 12, 2010: Report #2

This second insert on the Haiti earthquake covers engineering failures and the social impacts of the quake. The first report in the April issue covered seismology and geotechnical aspects, primarily. The EERI team responsible for this report, including members from partnering organizations — the Network for Earthquake Engineering Simulation, the Mid-America Earthquake Center, Florida International University, Sherbrooke University, University of Delaware's Disaster Research Center and Western Washington University's Resilience Institute — visited Haiti from February 28 through March 7, 2010. The 18-member multi-disciplinary team included engineers, social scientists, city planners, architects, and geographers. The EERI team worked with the ASCE Technical Council on Lifeline Earthquake Engineering team and, together, the teams visited over 500 facilities and buildings in the heavily hit areas of Port-au-Prince, Léogâne, Petit Goâve, and Jacmel. The EERI team and its partners consisted of Reginald DesRoches, Georgia Institute of Technology (team leader); Susan Brink, University of Delaware; Peter

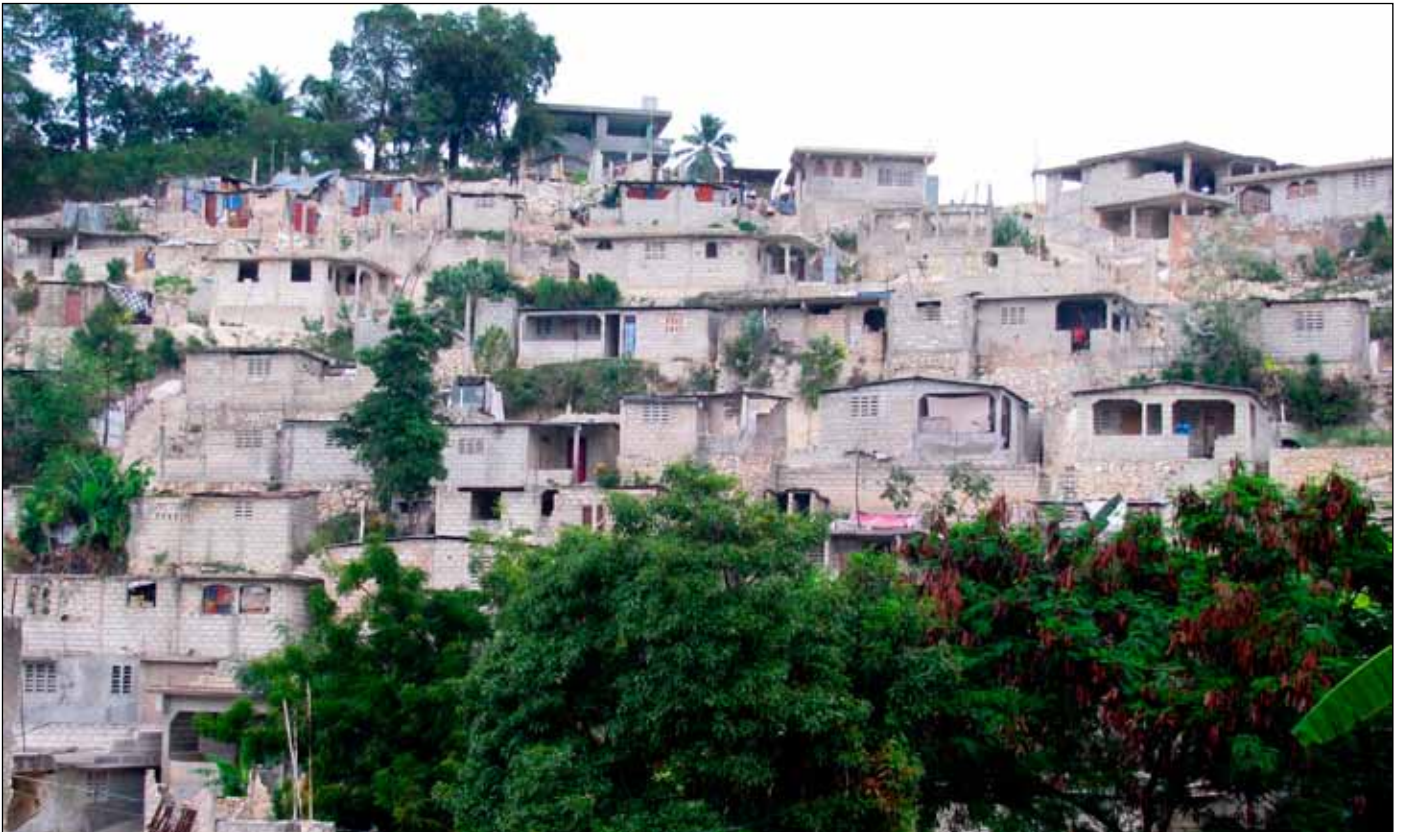
Many residences are constructed over a significant length of time as the homeowner acquires funds or the family's needs expand. Most are designed and constructed by the owner or a local mason. Residents sometimes squat on land, public or private, to be near family, friends, or their employment. These unauthorized developments, known by the French term *bidonville*, are found on hillsides surrounding Port au Prince and Petionville, as well as in low-lying coastal areas such as Cite Soleil (Figure 11).

Figure 11. Typical residential bidonville in the hillsides above Port-au-Prince (photo: Anna Lang).

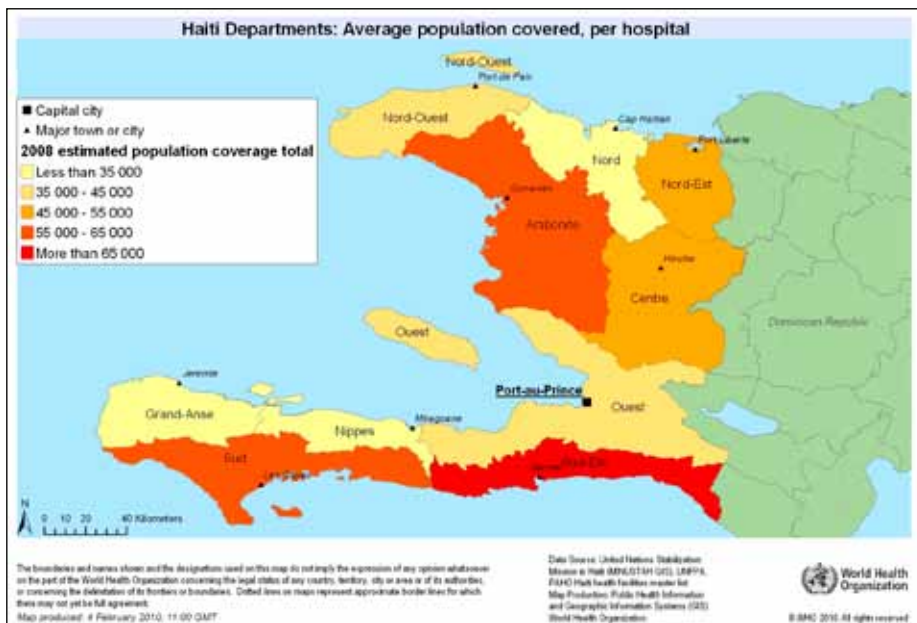
Figure 16. Average population covered per hospital by Haiti Departments, from web page www.who.int/hac/crises/hti/maps/haiti_population_per_hospital_district_4feb2010.JPG.

prior to the earthquake there were 594 primary health care centers; 30 reference communal hospitals (30-60 beds each); six centers for integrated diagnostics; ten department hospitals (with 150 beds each); and three university hospitals (1,500 beds total. See Figure 16). In addition, numerous nongovernmental organizations (NGOs) in Haiti provided health care services, training for health care providers, and advice to Haitian health care administrators. PAHO had a core staff of 52 before the event, and sent an additional 60 people with expertise in disaster management, logistics, epidemiology, communicable disease control, and water and sanitation.

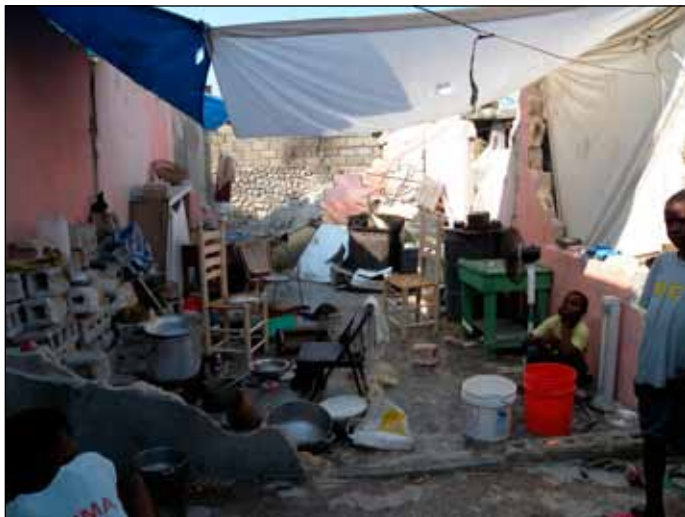
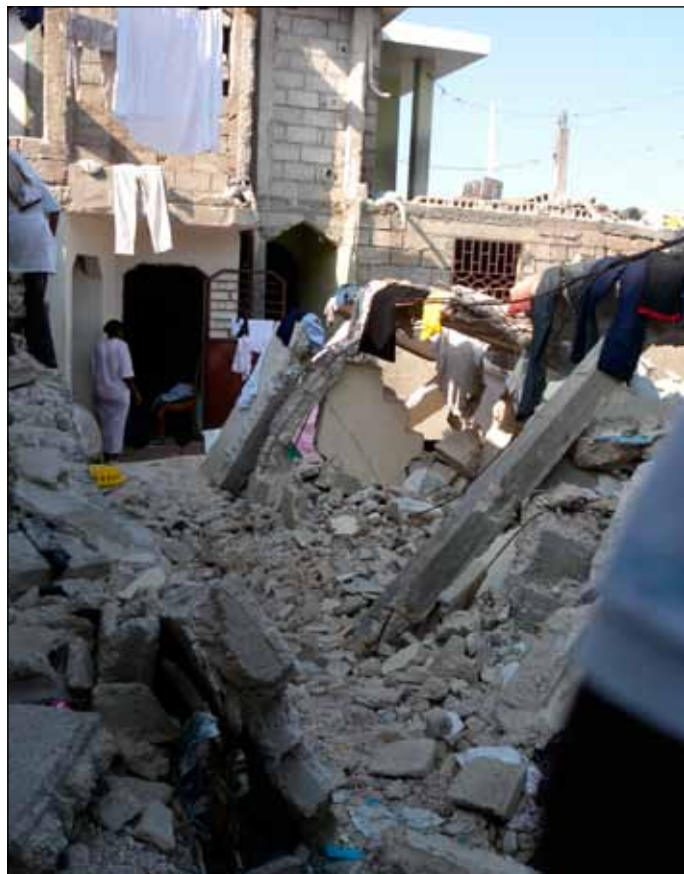
Figure 20 (a) ▲ and (b). ► Residents living in or next to damaged homes (photos: Rebekah Green).

homes (Figure 20). Most IDP camps were created spontaneously by individuals, with subsequent water, food, sanitation, and shelter support from NGOs (Figure 21). Many in the Port-au-Prince metro area are still without weather-resistant shelters.

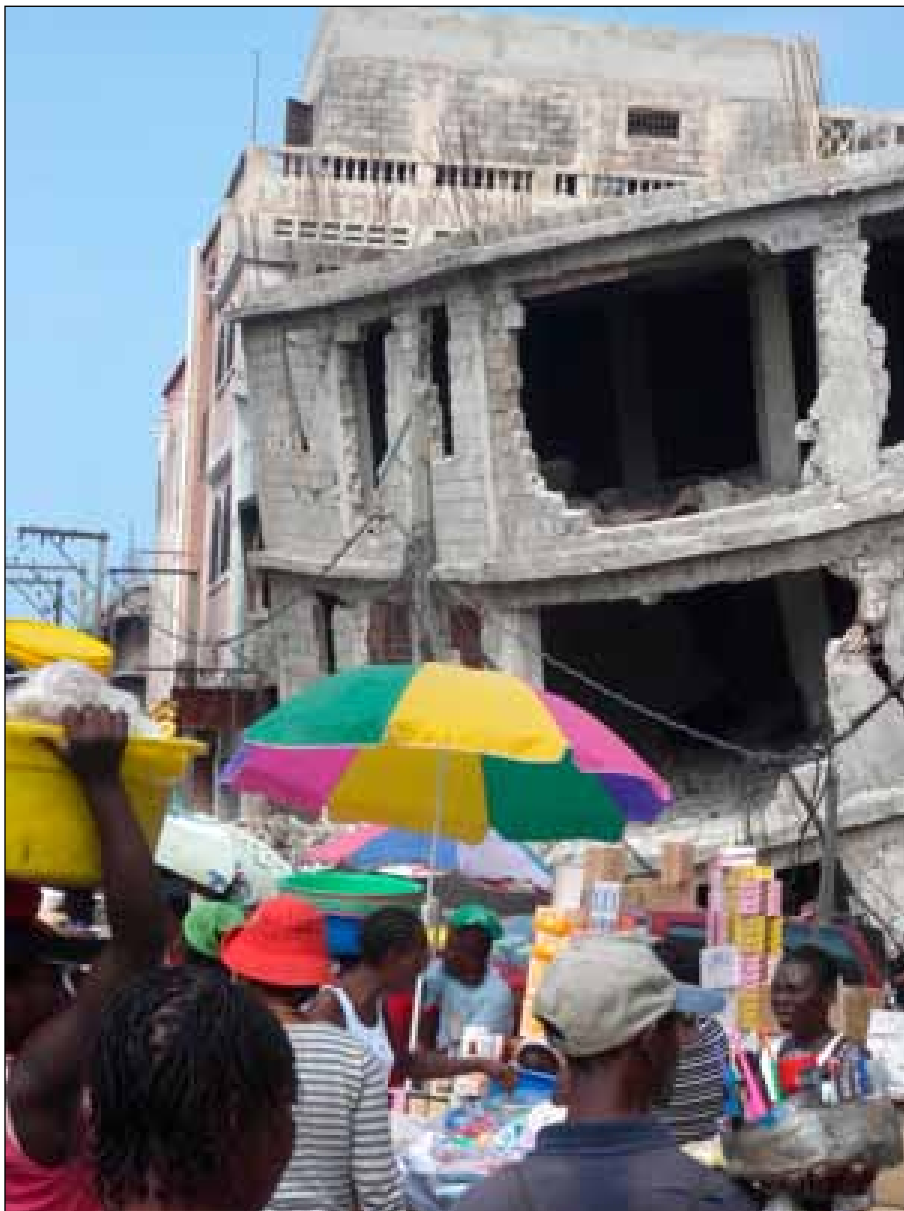
Figure 23. Displaced Iron Market vendors selling goods in downtown Port-au-Prince (photo: Scott Miles).

Despite the widespread damage in the Port-au-Prince metro area, the formal and informal economy is operating, albeit at reduced levels. Street markets survived the quake, and many new markets have appeared in and adjacent to tent camps (Figure 23). In the Port-au-Prince metro area, it was common to see street vendors selling everything from art, clothing, and baby products to salvaged construction material, tarps, and mobile phone charging services. We observed use of social networks outside of

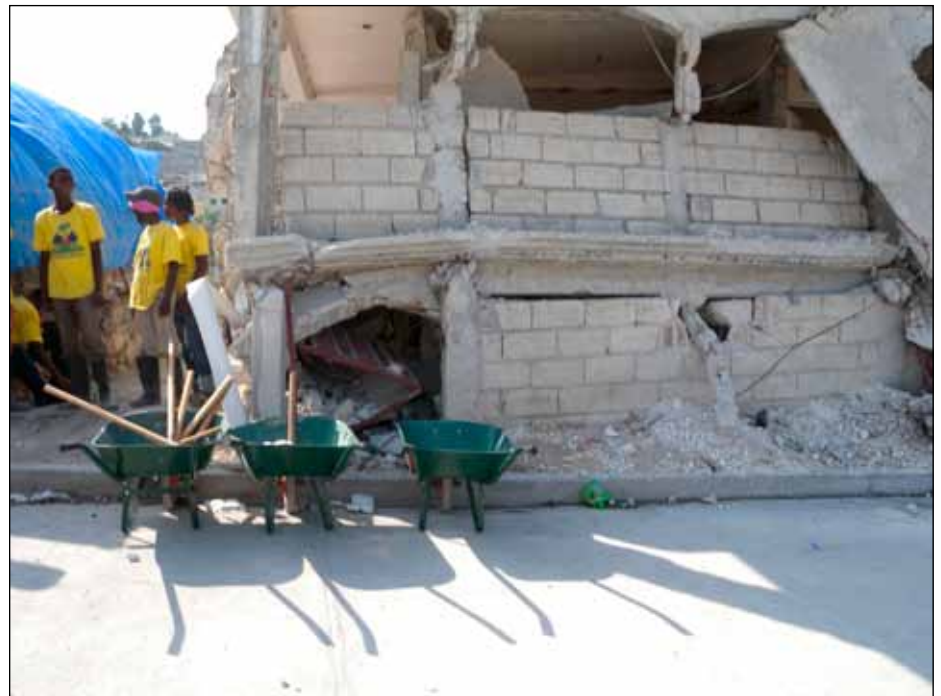
Figure 25. Limited equipment available for debris removal (photo: Rebekah Green).

Debris removal and management: The Early Recovery Cluster is actively planning and implementing a plan for debris removal, with a current focus on roads and drainage ditch clearance. However, the amount of debris exceeds available resources for removal (Figures 24 and 25). The availability of heavy equipment is extremely limited in Haiti, with only two Haitian government agencies operating it; private sector equipment is very expensive. Foreign militaries provided heavy equipment for early debris removal (Figure 26), but many are now pulling out of Haiti. Although some heavy equipment is being donated locally and internationally, the problem of disposal remains.
