## Learning from Earthquakes

# The M 6.3 Christchurch, New Zealand, Earthquake of February 22, 2011

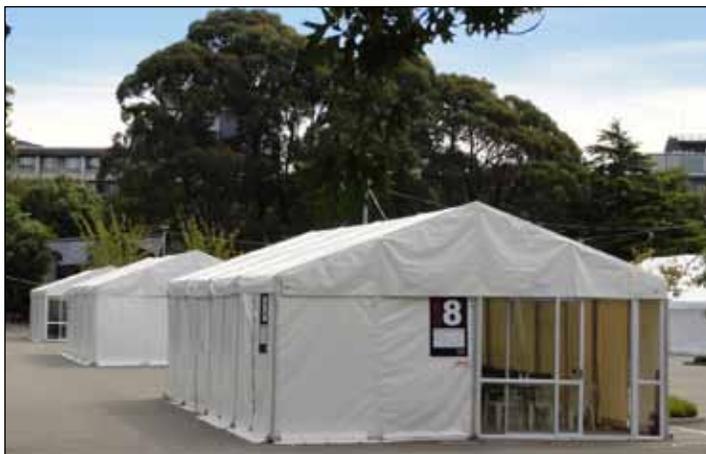
**Figure 19.** Classroom tents in the car park of the University of Canterbury, March 14, 2011 (photo: Comerio).

The University of Canterbury (UC) progressively reopened within 3-4 weeks of the earthquake while promising to deliver a high-quality, full academic year program of teaching and offering grants to compensate students. Across all educational institutions, alternative classroom capacity was created with temporary classrooms (Figure 19), off-site venues, site sharing, correspondence

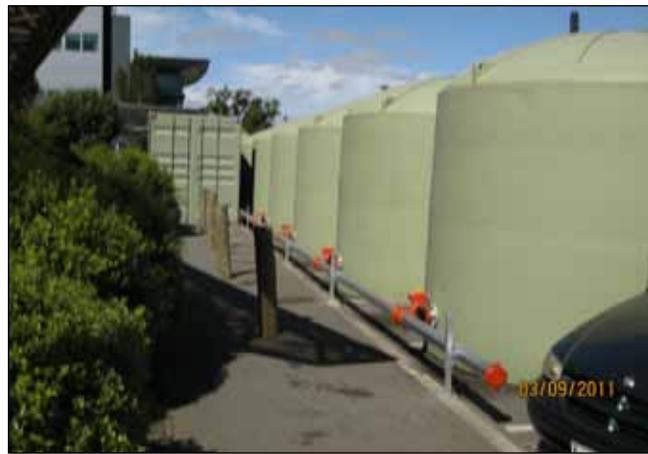
**Figure 20.** Temporary water tanks in front of Christchurch Hospital (photo: Gavin).

**Hospital.** The Christchurch Hospital—the South Island's largest tertiary hospital with 600-650 beds—suffered little structural damage, but had to evacuate 160 patients and request support from other facilities to cover functions such as laundry service. The hospital's backup power generators failed due to sludge clogging the filters, forcing patients to be evacuated from the main ward. The hospital also had to move patients from the fourth and fifth levels of the Riverside building due to leaks caused by sprinkler damage. Pipe failures were also discovered in the sewage system. Ceiling damage was prevalent in older buildings with heavy plaster tiles, while lightweight ceilings performed well. The hospital was also suffering from a lack of water pressure due to liquefaction damage to the tunnel housing pipes that carry steam from the boilers across the street to the hospital; as a precaution, the hospital has brought in storage tanks with almost 53,000 gallons of water (Figure 20). There were several instances of mechanical equipment jumping off mounts, as well as overturned furniture. One building on the hospital's campus, the Hagley Nurses Hostel,

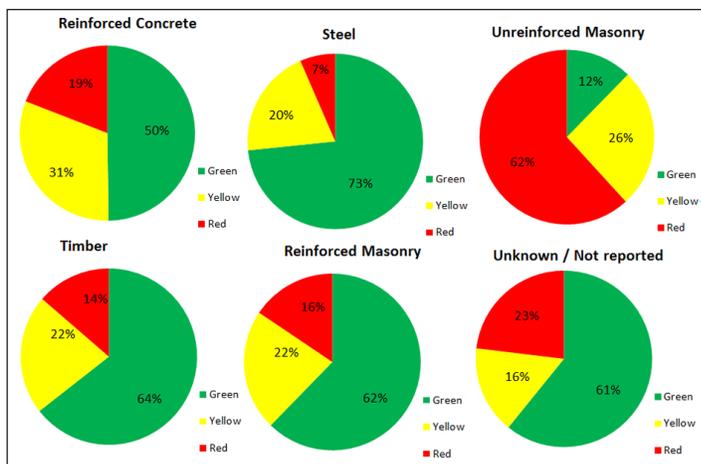
As of April 15, more than 60,000 total assessments have been accomplished, with the following breakdown of red tagged buildings: 1788 residential buildings, 1109 buildings within the CBD, including 395 heritage buildings (Civil Defence 2011). Figure 22 shows the

**Figure 22.** Building Assessments in Central Business District (Kam et al. 2011, Data source: Christchurch City Council)
