# CALTRANS BRIDGES DURING WHITTIER 1987 EARTHQUAKE

ROUTE 605/5 SEP. (BR No. 53-1660)

A short Seismic Report from the Office of Structures Design by the Post Earthquake Investigation Team describes the number of bridges affected by the Whittier event. The details of damage to the Route 605/5 Separation bear repeating:

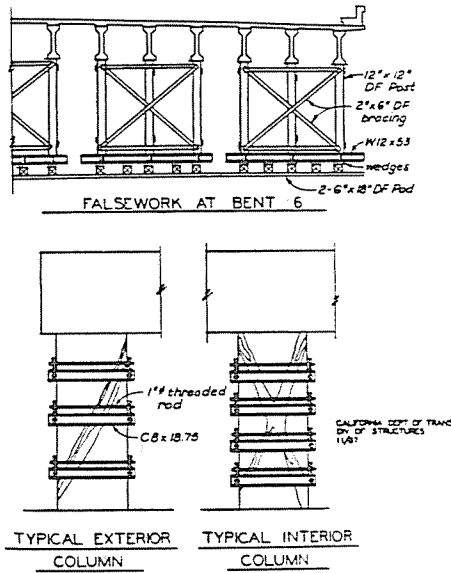
The most damaged area was Bent 6, the center support for the two main spans. All 5 columns were damaged with the three interior more damaged than the 2 exterior columns. Major cracking occurred on the east and west faces (wide sides) of

all columns. Minor cracks were observed on the north and south faces (short sides). The shear reinforcement in the middle column fractured at two levels and necked at another; however there was no evidence of rebar fracture in the remaining four columns. Also there were cracks in the bent cap adjacent to the most southerly column (column #5).

Structures Maintenance Engineers, on the scene in less than an hour, determined that this structure was unsafe for traffic. Both Route 605 and Route 5 traffic was detoured around the bridge. Due to the extent of the column damage and the potential for aftershocks, Structures Maintenance decided to construct temporary falsework bents. By combining the resources of Bridge and Road Maintenance crews and a Bridge Contractor, under the supervision of Structures Construction, falsework bents were placed, K-rail was placed, and Route 5 traffic lanes were restriped. Within an amazingly short time, 22 hours after the quake occurred, the 605/5 Separation was reopened to traffic.
