THE CENTRAL PERUVIAN EARTHQUAKE OF AUGUST 15, 2007 : A PRELIMINARY REPORT

The Central Peruvian Earthquake of August 15, 2007 : A Preliminary Report

Prof. Richard E. Klingner
The University of Texas at Austin
Member, Reconnaissance Team
Peru - Japan Disaster Mitigation Center

Structures Seminar
The University of Texas at Austin
August 29, 2007

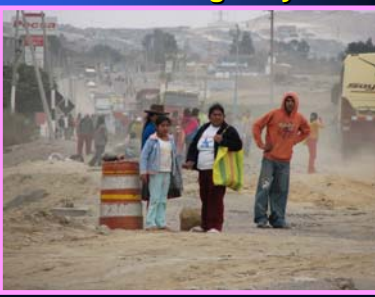
Our 250-km journey was complicated by earthquake damage to the Pan-American Highway

- some families were walking toward Lima in search of food and water

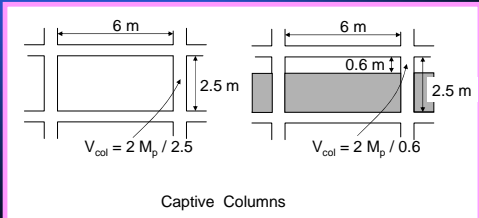
Captive Columns

problems with captive columns ...

- for a given flexural capacity, shear demand on column increases as column height decreases

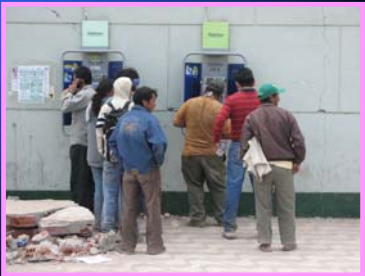
... Damage to social fabric

- some phone lines worked, but many didn't
- cell phones couldn't be charged
