World Housing Encyclopedia Report

Country: Taiwan

Housing Type: Street front building with arcade at the first floor (pre-1970's construction)

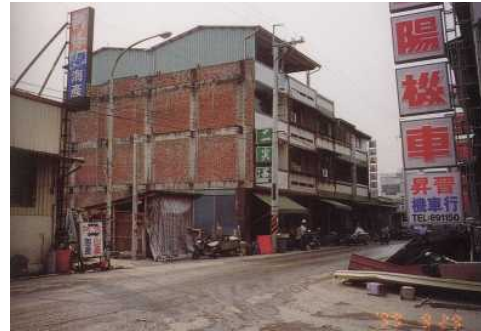
FIGURE 1: Typical Building

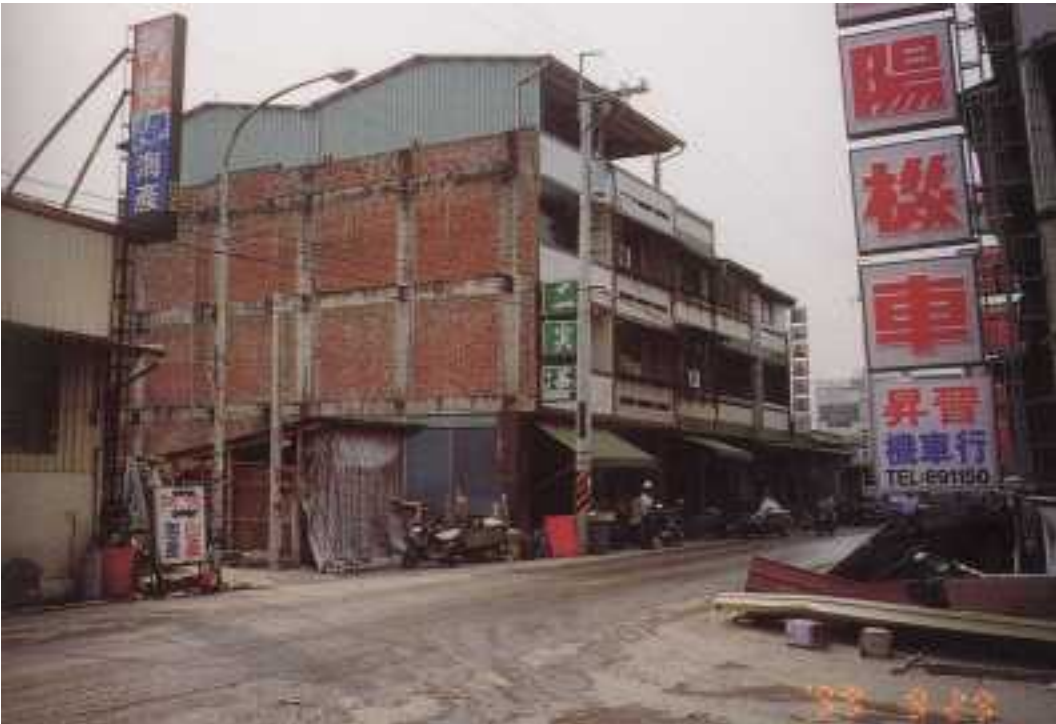
FIGURE 1: Typical Building

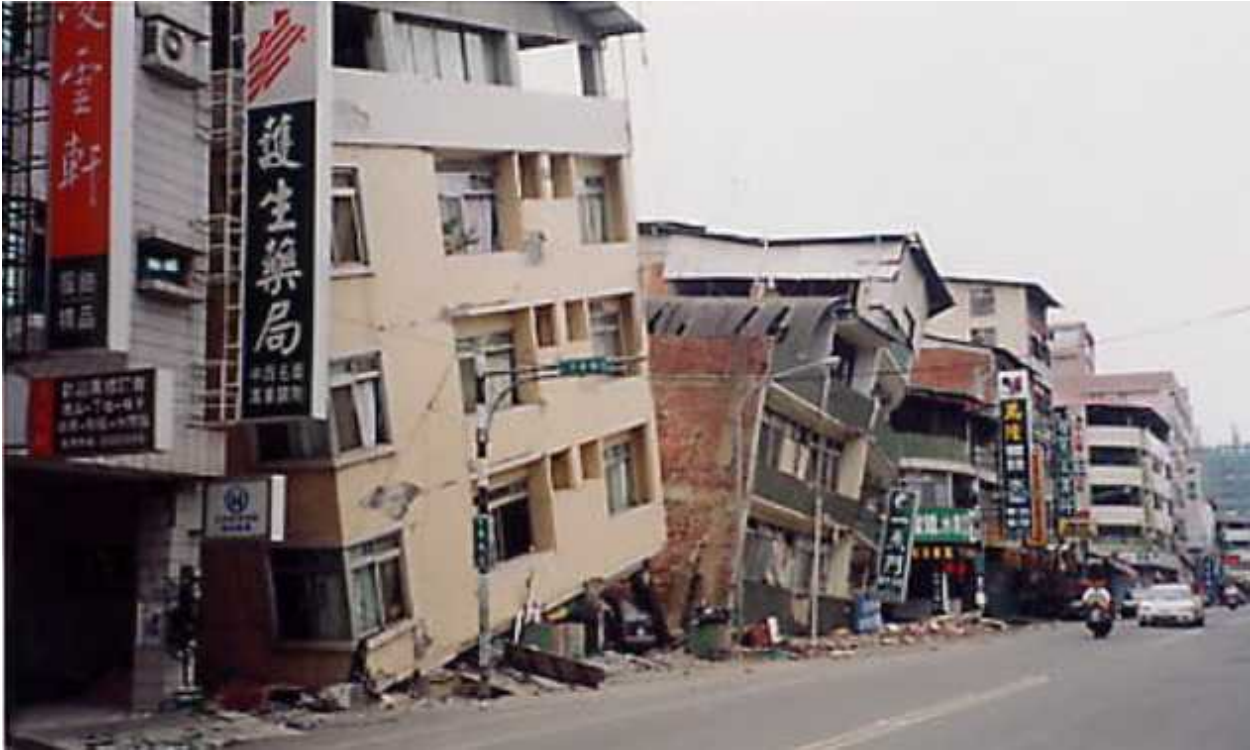
FIGURE 6A: A Photograph Illustrating Typical Earthquake Damage (1999 Chi Chi earthquake)

Roof and floors	No major deficiencies		
Building Configuration	The open front at the bottom story is the most obvious configuration irregularity characteristic for this construction type. This feature creates undesirable soft-story and torsional effects, as illustrated in Figure 5A (Source: EERI 2001).		Extensive damages and building collapses due to the large demands on the bottom story columns caused by soft story and torsional effects (see Figure 6A)

Additional Comments: Although many buildings of this construction type sustained significant damage in the 1999 Chi Chi earthquake, most of them performed satisfactorily. Earthquake damages are illustrated in Figure 6A. The main causes for damage observed after the earthquake are (EERI, 2001): 1) Poor configuration attributable to the open front combined with inadequate column lateral reinforcement (ties). The large displacement demands from the soft-story and torsional effects often damaged the plastic hinge regions of the columns at the open front. All damaged columns were observed to have non-ductile confinement reinforcement details consisting of widely spaced horizontal hoops, more than 300 mm apart, and 90 degree hooks. Usually, the lack of confinement reinforcement in the plastic hinge regions resulted in brittle failure. In some cases, hinge rotation caused buildings to permanently lean out of plumb. In other cases, buildings with no signs of earthquake damage remained standing next to the seemingly identical buildings that sustained the total collapse of entire bottom stories. 2) There was also widespread damage to the unreinforced brick partitions and perimeter walls. Although partitions are usually considered nonstructural elements, the collapse of or damage to unreinforced brick partitions represents a significant falling hazards, and it forced many people out of their homes. 3) Performance of this construction type in the earthquake was significantly influenced by the infill wall layout. Because brick infills significantly influence the structural characteristics and yet are not considered in the design, the seismic performance of this building type is highly unpredictable. A five-story building of this construction type (constructed in the early 1970's) collapsed in the March 31, 2002 Taipei earthquake. The bottom two stories were flattened in the earthquake. Fortunately no one died in this building owing to the quick response of the rescue team established after the 1999 Chi-Chi earthquake in central Taiwan. According to a local newspaper, a garage shop purchased several units at the first floor. The first floor walls were torn down to satisfy the spatial needs of a garage. As a result, a weak story formed and the building leaned forward and collapsed in the first few seconds in the earthquake.

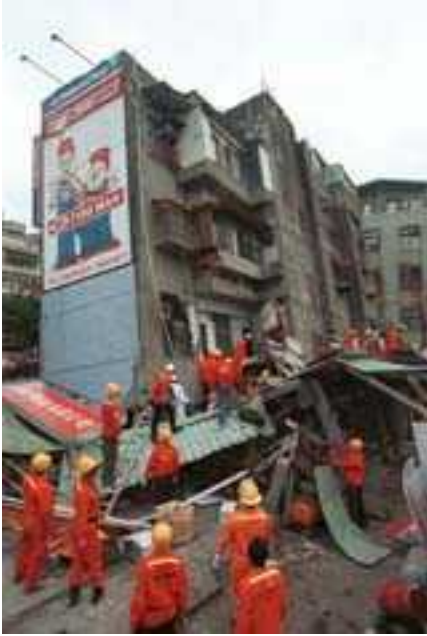
FIGURE 6C: Earthquake Damage - Collapse of a 5-story building in the March 31, 2002 Taipei earthquake
