**EARTHQUAKE ENGINEERING  
RESEARCH INSTITUTE  
NEWSLETTER**

**Algeria Hit by Earthquake on May 21, 2003**

**Earthquake off Japan Coast on May 26, 2003**

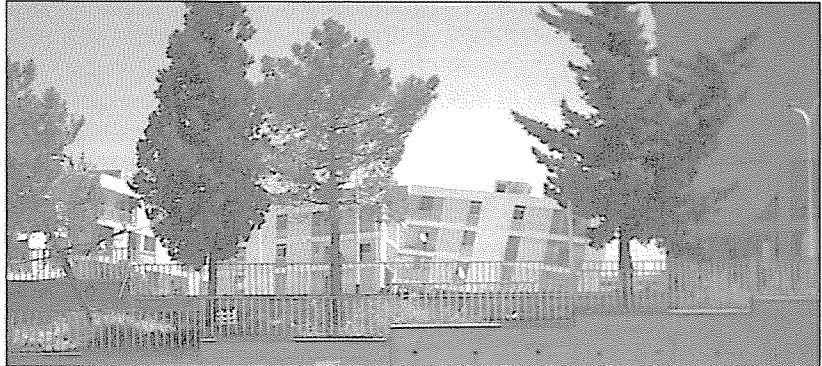
*Failure of a multistory residential structure in Algeria (photo courtesy of Michel Sandrin).*

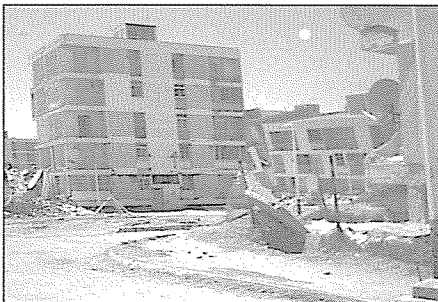
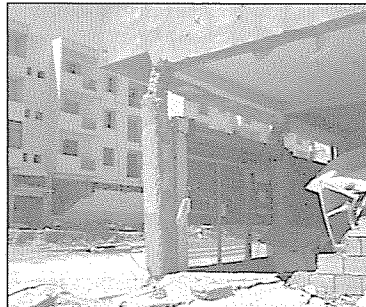
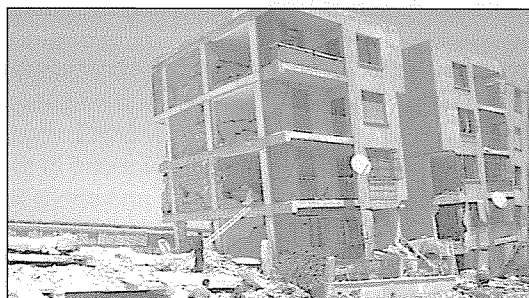
Up to 60 buildings are believed to have collapsed in Algiers. The tragedy of this earthquake was the failure of multistory apartment buildings (usually up to six stories high, including the ground floor). They are rental apartment buildings, built by the state, cooperatives (similar to condominiums), and privately built and owned houses. Structurally, the most frequent failure occurred to reinforced concrete frames with hollow brick infill walls, with complete collapse of ground floors supporting the heavy loads of the buildings above. While the quality of soil (mostly alluvium in the vicinity of the seashore and in the dry beds of numerous old creeks and small rivers that cover the area) definitely contributed to the structural behavior of buildings, poor building materials, inadequate detailing, and apparently a lack of proper supervision appear to be the main causes.

*Multistory buildings sustained damage due to failure of columns (photos courtesy of Michel Sandrin).*

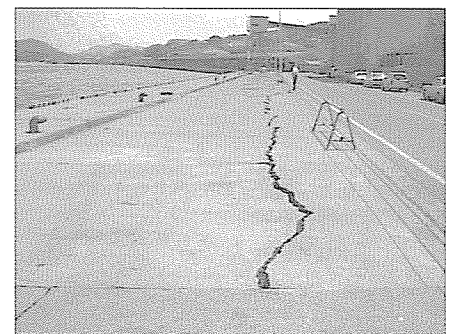
Also observed were some large cracks in roads, several landslides, and rock and debris falls. Damage occurred from foundation settlement and liquefaction. There was also interior and exterior nonstructural damage, including damage in many cemeteries. A typical failure was tombstone rotation or toppling. The economic loss is estimated at US\$97.3 million. The Tohoku Earthquake Disaster Investigation Committee will investigate ground motion, performance of buildings and lifelines, injuries, and damage to historical buildings. A link to Motokasa's full report can be found at EERI's home page at [www.eeri.org](http://www.eeri.org).

*Damage caused by foundation settlement in Ofunato (photo courtesy of National Research Institute for Earth Science and Disaster Prevention).*
