World Housing Encyclopedia Report

Country: Chile

Housing Type: Steel frame buildings with shear walls.

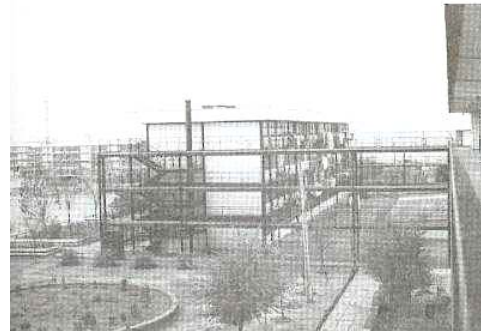
FIGURE 1A: Typical Building: Poblacion Republica popular China, located in Vina del Mar, an area affected by the March 3, 1985 earthquake. These buildings suffered no damage.

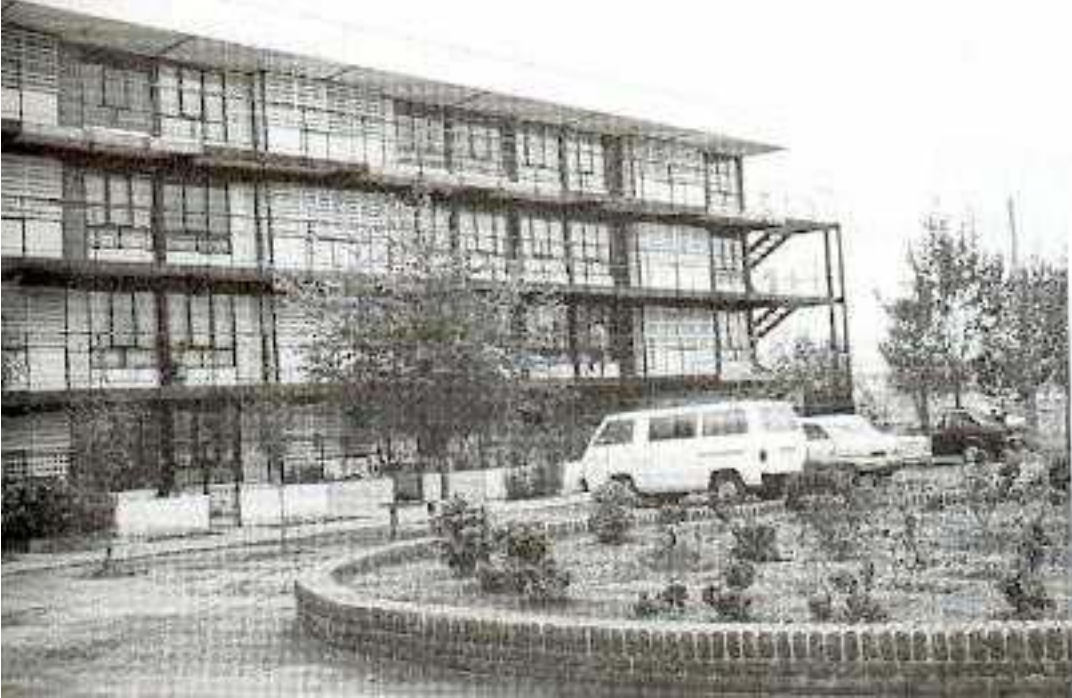
FIGURE 1B: Typical Building: Poblacion Republica popular China, located in Vina del Mar, an area affected by the March 3, 1985 earthquake. These buildings suffered no damage.
