Learning From Earthquakes

Geological Aspects of the October 9, 1995, Manzanillo, Mexico, Earthquake

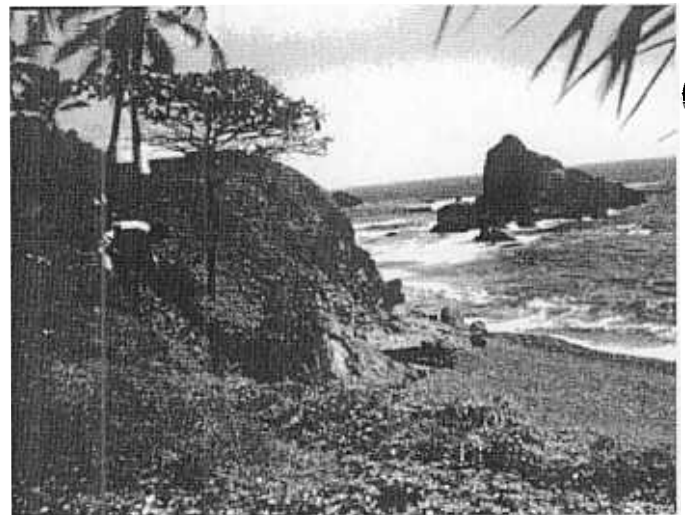
Figure 1 - The line of affected vegetation confirms eyewitness reports of a tsunami inundation of about 4.5 m at a site 10 km north of Manzanillo. No wave was reported, just a gradual rise of the water level.

A condominium complex, on a beach known as La Boquita, about 10 km north of Manzanillo, Colima, was also affected by the tsunami. The beaches of the complex were inundated and eyewitnesses and high water marks indicate the tsunami rose about 4.5 meters in this location. The witnesses reported five high water waves, each preceded by a recession. The third was the largest. The recession bluffs above the beaches and the high water marks can be determined by the line of affected vegetation (Fig. 1). Again witnesses reported no large wave, just a gradual rise of the sea level to the high water mark.
