## **DECEMBER 26, 2004 TSUNAMI IMPACTS ON COASTAL THAILAND**

By Curtis Edwards, PE – Pountney Psomas  
Yumei Wang, PE – State of Oregon

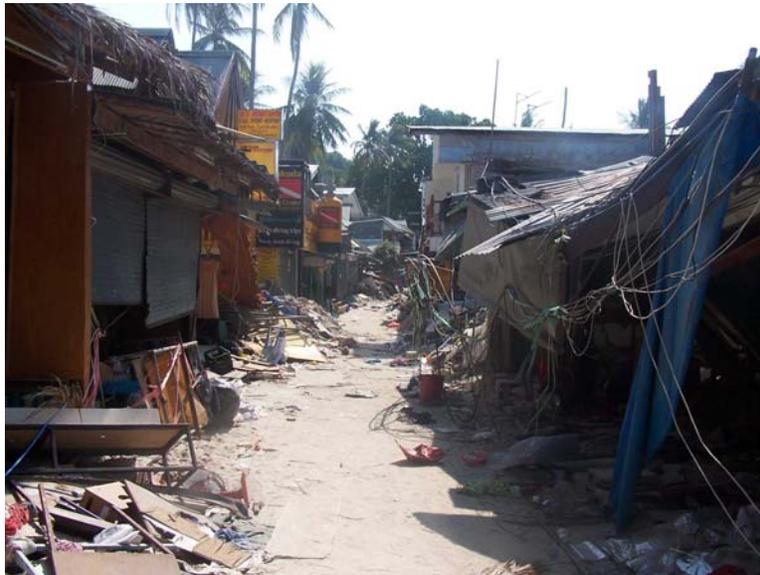
11Phi Phi Island Damage – 07° 44.379N; 98° 46.335E

In stark contrast to the "mainland" recovery efforts, Phi Phi Island, where approximately 3,000 people were killed, is only now beginning to recover. This island is mostly privately owned and requires boats or helicopter access. As a result, recovery has been slow. Originally, the provincial government would not allow the disposal of collected debris. This decision was reversed around February 1 and now clearing and disposal by barge is progressing.

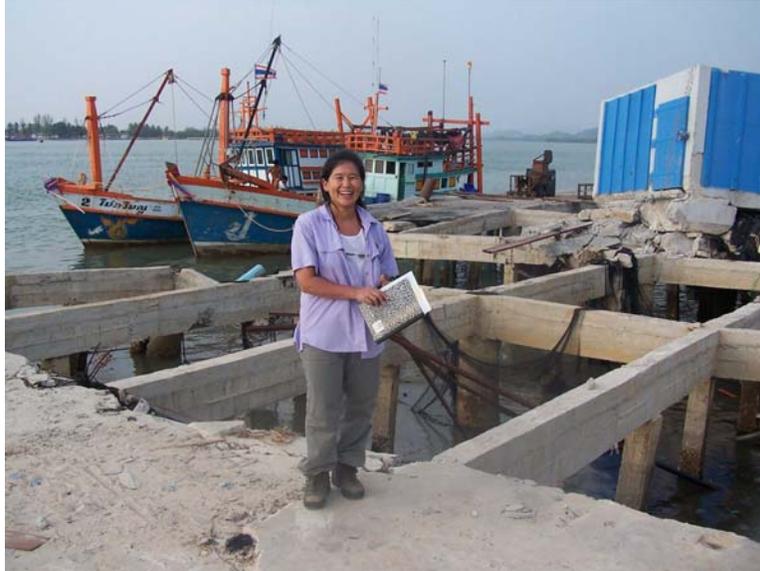
11 Damaged Fishing Pier - 08° 34.226N; 98° 13.439E

A fishing port, Ban Nam Ken, north of Khao Lak, had extensive damage to concrete piers and nearly all the fishing fleet either destroyed in place or washed a km inland. The local Navy base was severely damaged by the tsunami waves. Ships were beached and shore facilities flooded. The Navy's water treatment plant and electrical generation facility were damaged. This hindered the Navy's ability to aid in the tsunami response efforts.

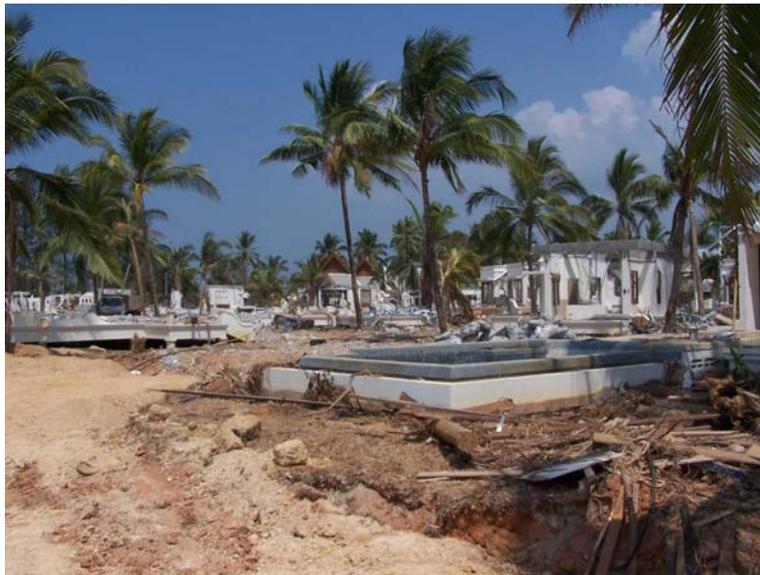
11 Khao Lak - 8° 41.45N; 98° 14.49E

Khao Lak, a new upscale resort area north of Phuket, was completely devastated by waves that exceeded 10-m high in places. Resort infrastructure was almost total destroyed and all hotels are closed for extensive repair. Foundations were scoured, walls collapsed by wave pressure, and roof tiles removed by wave impact.
