Bengkulu & West Sumatra Earthquakes, September 12, 2007, Structural Damage Report

Teddy Boen*

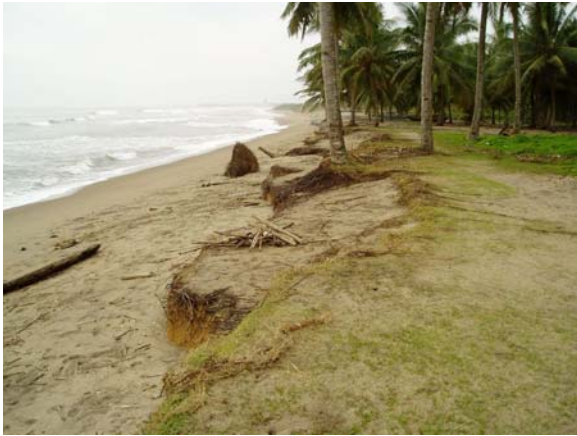
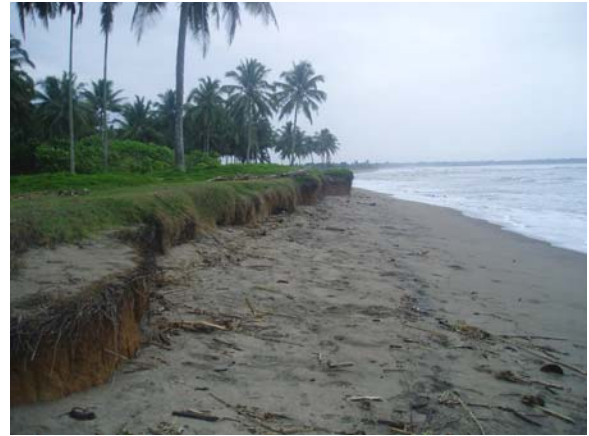
Pondok Kelapa Village, Lais, North-Bengkulu

Figure 3. (Cont'd): No indication of tsunami along the beach

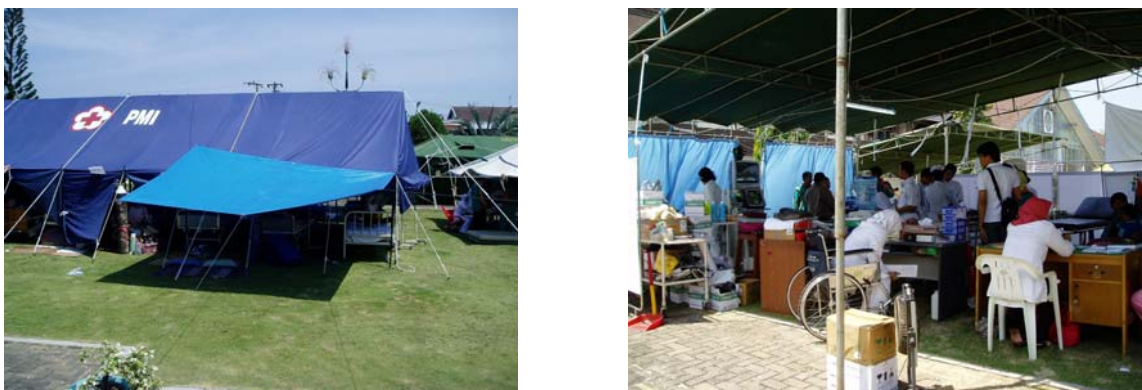
Figure 8.: Tents outside M. Yunus hospital, Bengkulu

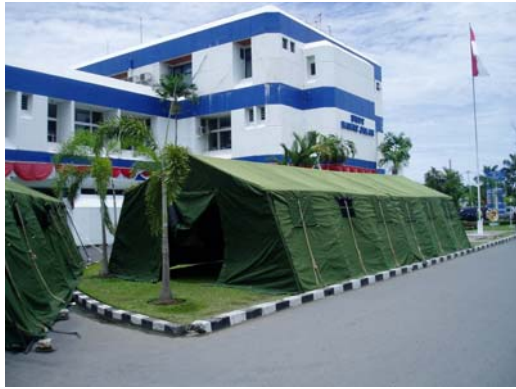
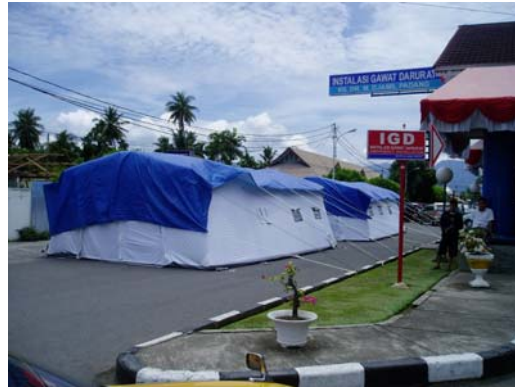
Figure 9.: Tents outside M. Djamil hospital, Padang, West-Sumatra

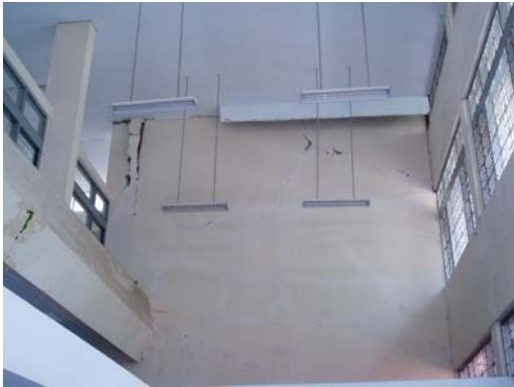
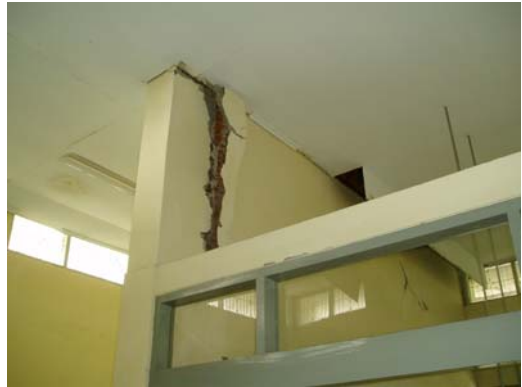
Bengkulu Pos Office

The main cause of damage and / or collapse was because the buildings were not designed to withstand the seismicity of West Sumatra. Also poor quality of concrete and detailing contributed to the collapse of those engineered buildings. Some other “engineered” buildings suffered minor damage. In general it can be stated that the damage to engineered buildings due to the September 12, 2007 and September 13, 2007 earthquakes were negligible. This is understandable because the epicenter is some 125 km away from the West Sumatra and Bengkulu. As was the case during the Aceh Dec 2004 earthquake, only poorly built engineered buildings were damaged or collapsed.

Figure 10. (Cont'd): Damage of engineered buildings

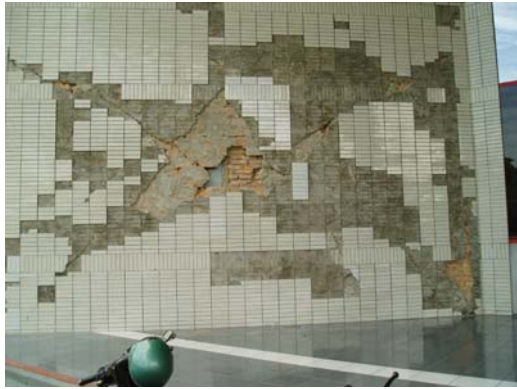
Telkomsel building, Padang, West-Sumatra

Figure 10. (Cont'd): Damage of engineered buildings

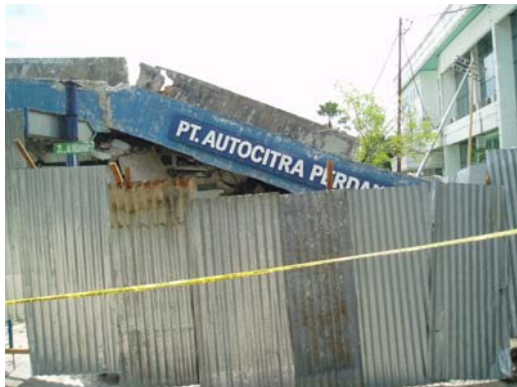
Showroom Hyundai, Al-Hidayah Rd. Padang, West-Sumatra

In Padang, two showrooms collapsed. In Bengkulu, one “engineered” school building, SMAK Sint. Carolus, was damaged. This building was also damaged due to June 4, 2000 Bengkulu earthquake. One building was demolished and replaced by the new one. In the September 12, 2007 earthquake, the roof of the newly constructed building collapsed.

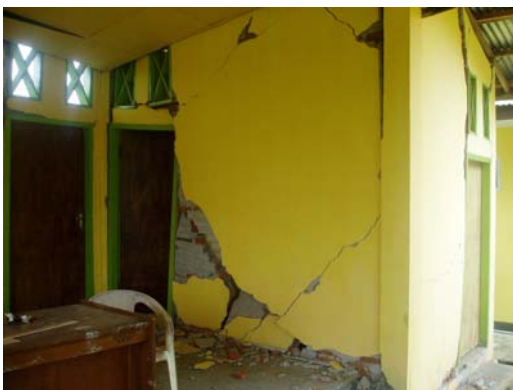
Pal 30 Village, Lais, North-Bengkulu

Figure 14.: Diagonal cracks in walls due to out of plane loading

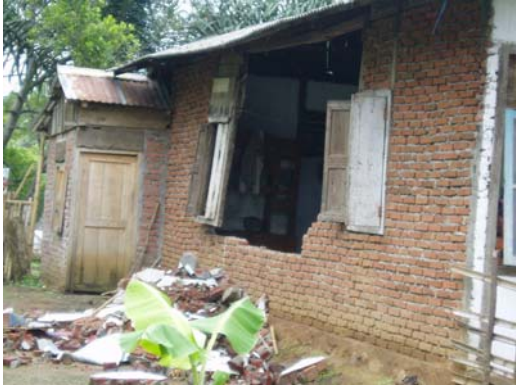
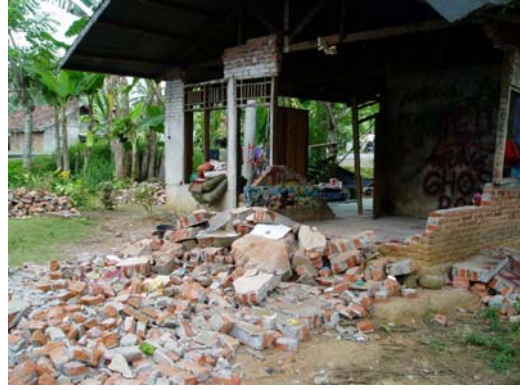
Pondok Kelapa Village, Lais, North-Bengkulu

Figure 15.: Walls collapse due to out of plane loading

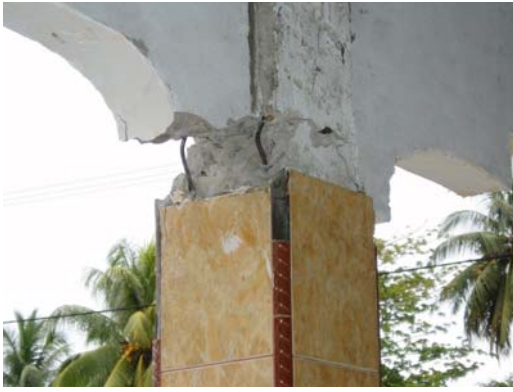
Pasar Palik Village, Lais, North-Bengkulu

Figure 16.: Poor reinforcement detailing and poor workmanship

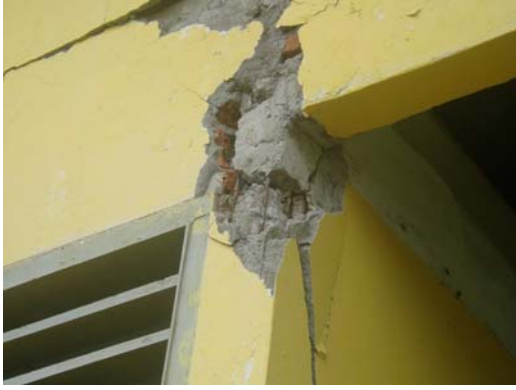
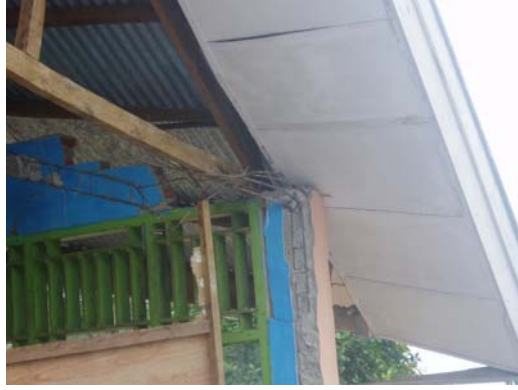
SMUN 1, Pal 30 Village, Lais, North-Bengkulu

Figure 16. (Cont'd): Poor reinforcement detailing and poor workmanship

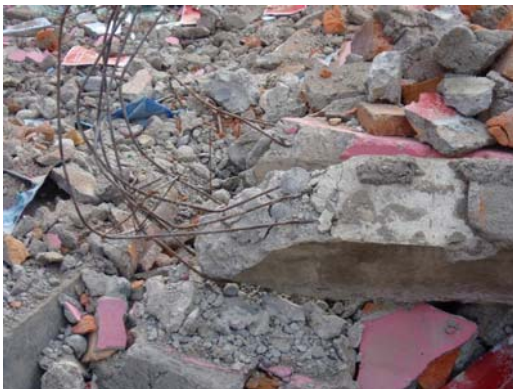
Lubuk Sanai Village, Muko-Muko, North-Bengkulu

Figure 16. (Cont'd): Poor reinforcement detailing and poor workmanship

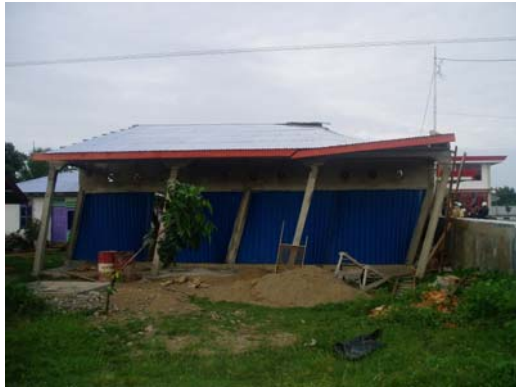
Front view

Figure 17.: “First soft story” type of failure

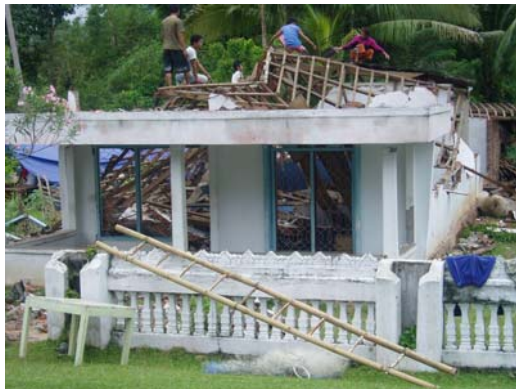
Pasar Palik Village, Lais, North-Bengkulu

Figure 18.: Totally collapsed buildings

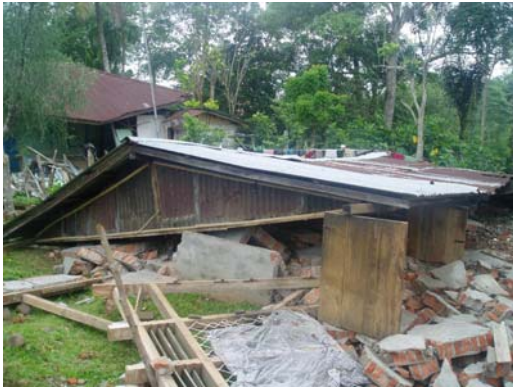
Kota Agung Village, Lais, North-Bengkulu

Figure 18. (Cont'd): Totally collapsed buildings

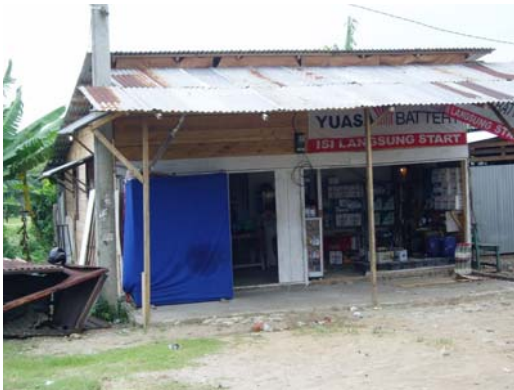
Lempuing, Bengkulu

There were few timber houses consisting of a timber frame and also timber planks walls and usually use galvanized iron sheets as roof. This type of buildings will gradually be abandoned and replaced by the confined masonry as soon as the owner manages to secure the fund. Timber buildings in general are earthquake resistant and survived the September 12, 2007 and September 13, 2007 earthquakes. Some timber buildings were damaged or collapsed because of deterioration due to lack of maintenance.

Figure 20.: Timber houses

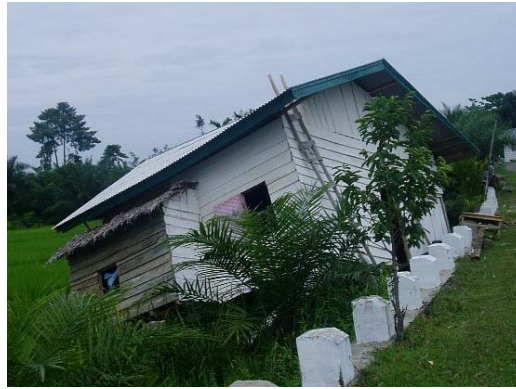
Linngosari Baganti, Pesisir Selatan, West-Sumatra

Figure 21.: Timber house collapsed due to lack of maintenance

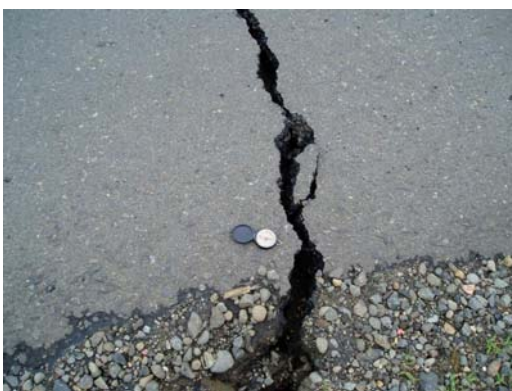
Kota Agung Village, Lais, North-Bengkulu

Although some non-engineered masonry buildings were damaged by the September 12, 20007 and September 13, 2007 earthquakes, almost all infrastructures are practically intact. Several cracks were observed particularly at Lais along the road from Bengkulu to Lais. However the cracks occurred in limited areas only. There was indication of potential landslides along the roads.

Figure 22.: Cracks along roads from Bengkulu to Padang

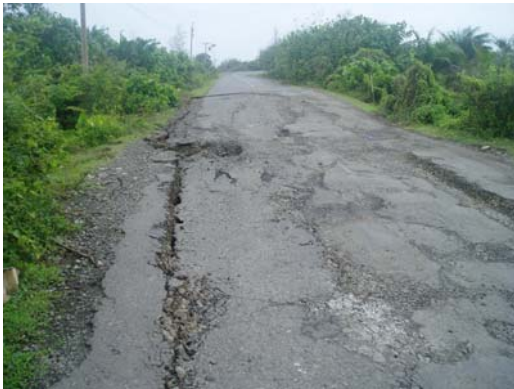
Roads along Lais to Ketahun

Figure 22. (Cont'd): Cracks along roads from Bengkulu to Padang

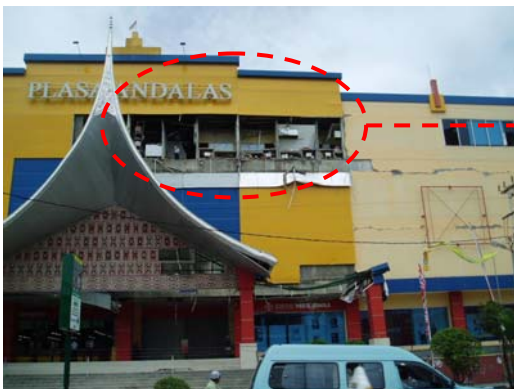
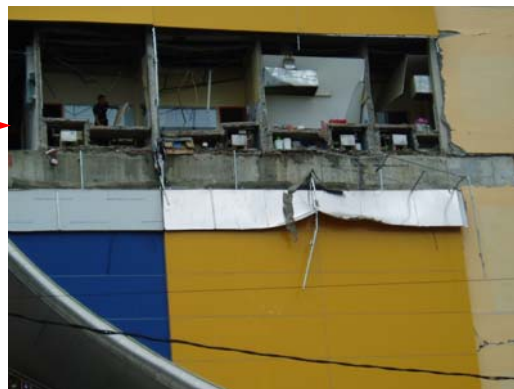
Right after the earthquake, the top part of Plasa Andalas, a market in Padang caught fire due to the overturning of a gas stove. However the fire could be contained and extinguished and did not spread to other buildings. The fire originated from an overturned gas stove of a restaurant located at the top part of Plasa Andalas.

Figure 27.: The top part of Plasa Andalas, a market in Padang, caught fire right after the earthquake
